**REPORT NO.
UCD/CGM-97/03**

GROUND IMPROVEMENT ISSUES FOR THE POSEY & WEBSTER ST. TUBES SEISMIC RETROFIT PROJECT: LESSONS FROM CASE HISTORIES

APRIL 1997

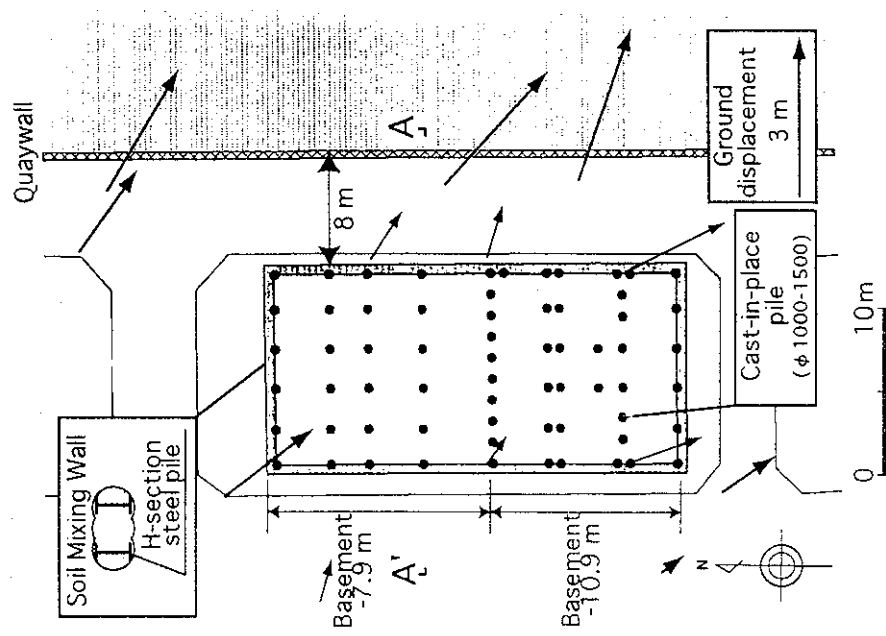
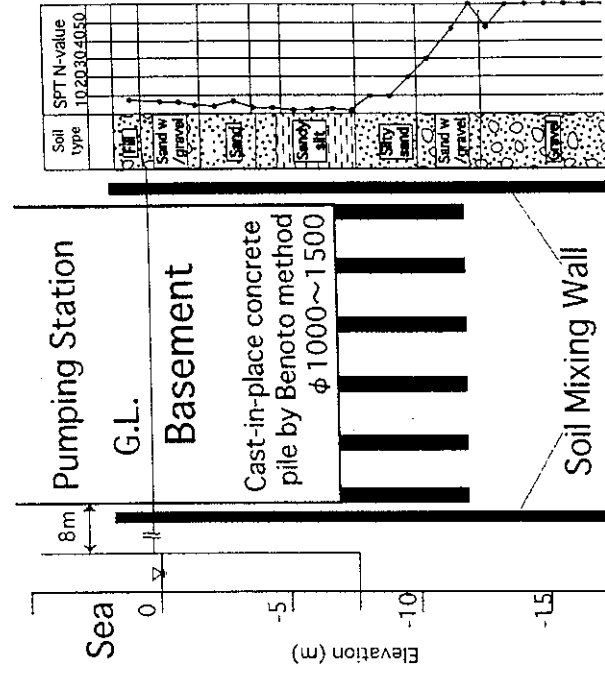
Fig. 3-1. Plan of Shimagami Pumping Station and Liquefaction-Induced Ground Displacement (Hamada and Wakamatsu 1996)

The Shimagami Pumping Station in Nagata Ward in Kobe experienced hardly any damage during the 1995 Hyogo-ken Nanbu earthquake despite extensive liquefaction in the surrounding soils (Hamada and Wakamatsu 1996). The Station building is located within 8 m of a quay wall that moved outwards up to 3 m, and the ground surface settled more than 1 m adjacent to the building (Figure 3-1). This 16 m high building has a basement that extends 8 m below the ground surface on the north side, and 11 m below the ground surface on the south side (Figure 3-2). The basement excavation involved construction of a perimeter in-ground-wall (Soil Mixed Wall, or SMW type) that was 0.45 m wide, about 18 m deep, and reinforced with steel H-section piles. This in-ground-wall was left in place after construction was completed. The building itself was supported by 1.0 to 1.5 m diameter cast-in-place concrete piles. The soil profile consisted of about 10.5 m of loose sandy fill, overlying sand with gravel and gravel that extends to depths of more than 20 m. This underlying gravel layer is considered nonliquefiable, and has N_{1-60} values greater than 30 below about 12 m depth. Hamada and Wakamatsu (1996) suggested that the "in-ground wall had a great influence to prevent damage to the foundation piles, in addition to existence of the basement." Note that Hamada and Wakamatsu also had presented data showing that buildings with basements had generally experienced less differential settlements than buildings without basements.

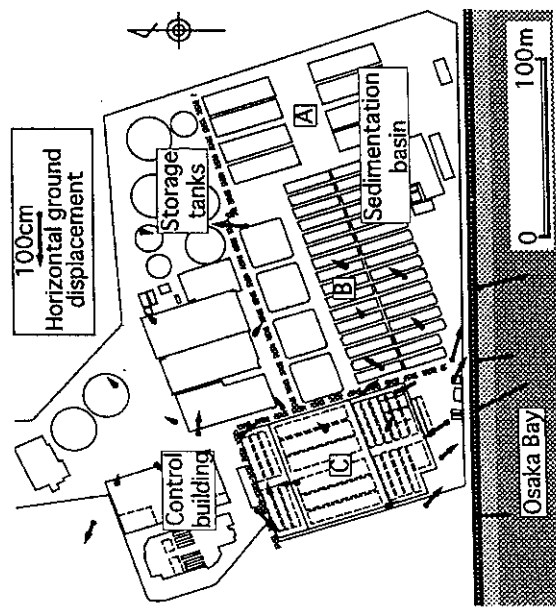
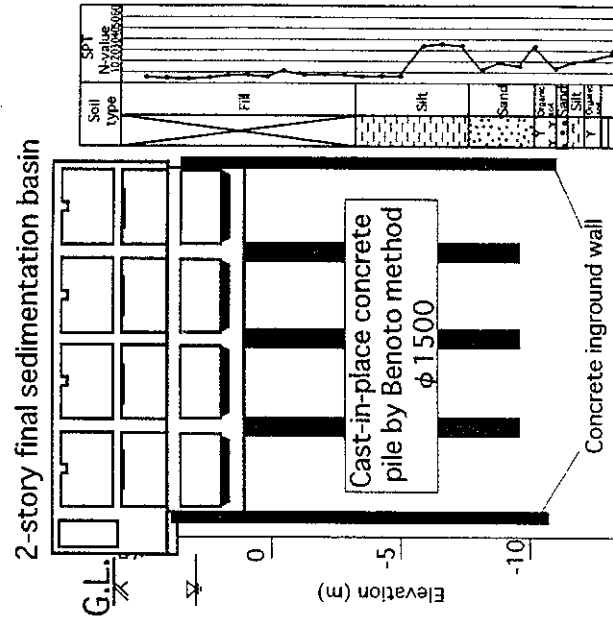
Fig. 3-3. Plan of Seibu Sewage Treatment Plant and Liquefaction-Induced Ground Displacement (Hamada and Wakamatsu 1996)

The Seibu Sewage Treatment Plant in Kobe has three sedimentation basins, of which basins A and B experienced large separations in concrete casting joints during the 1995 Hyogo-ken Nanbu earthquake, while basin C experienced no damage (Hamada and Wakamatsu 1996). The basins are located near quay walls that moved about 2 m outwards due to liquefaction of the

surrounding fill (Figure 3-3). Basin C had 2 basements that together extended about 6 m below the ground surface, which is much deeper than for the other two basins. Excavation of the basement for basin C involved construction of an in-ground-wall around the perimeter (Figure 3-4). The in-ground-wall was shown to extend to about 17 m deep, but details of the wall thickness, construction method, or possible reinforcement were not given. The basin building was founded on 1.5 m diameter cast-in-place concrete piles. The soil profile consists of about 10 m of loose sandy fill, overlying 4 m of silt (N values ranging from 8 to 35), and then underlain by inter-layered sand and silt to the depths of interest. As for the Shimagami Pumping Station, it appears that the good performance of this building may be partly attributed to the presence of the in-ground-wall, but that the presence of the basement and large-diameter piles would also be expected to have played an important role.

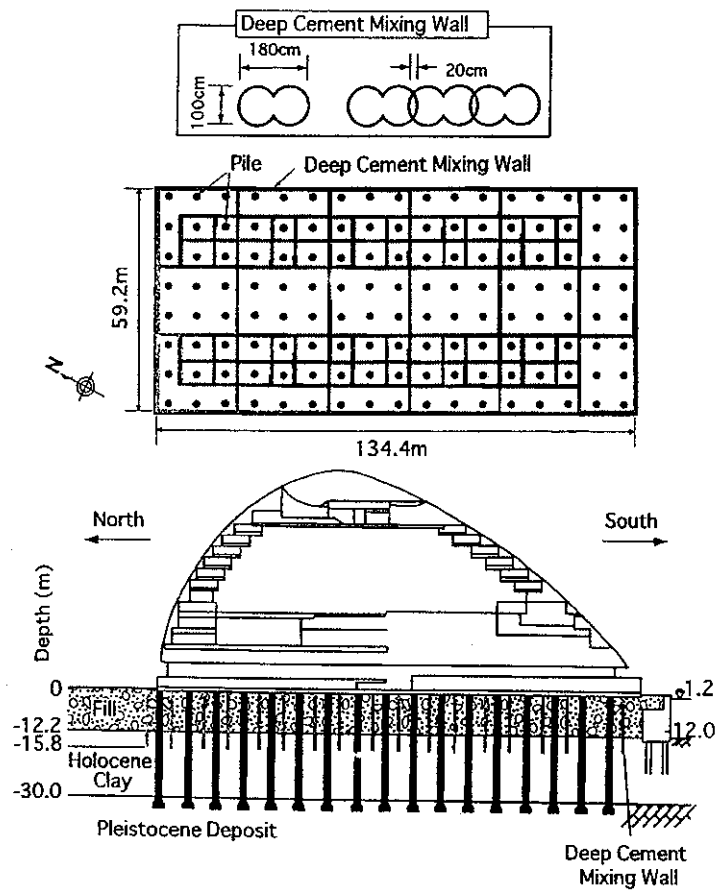
Fig. 3-5. Cross-Section and Plan of Oriental Hotel (Hamada and Wakamatsu 1996)

The Oriental Hotel is a 60 m high building located on the Central Pier of Kobe Port (Hamada and Wakamatsu 1996). The quay walls around the perimeter of the pier were heavily damaged with movements greater than 1 or 2 m due to liquefaction of the surrounding fill. The soil profile consists of about 12 m of loose sandy fill, overlying about 18 m of Holocene clay, and underlain by firm Pleistocene gravel. The hotel has no basement, and was supported by 1.0 m diameter, 30 m long, cast-in-place concrete piles bearing in the firm gravel. In-ground-walls, about 1.0 m wide, were constructed by overlapping 1.0 m diameter, 12-19 m long, mixed-in-place soil-cement piles (Figure 3-5). There was no structural damage to the building and no settlement within the in-ground-wall area after the 1995 Hyogo-ken Nanbu earthquake. In addition, there was no evidence of liquefaction on the ground surface when the building foundation was excavated after the earthquake. Thus, the evidence indicates that the in-ground-walls were very effective in protecting the foundation of this building from liquefaction-induced deformations despite the large deformations that developed around, and immediately adjacent to, the building's perimeter.

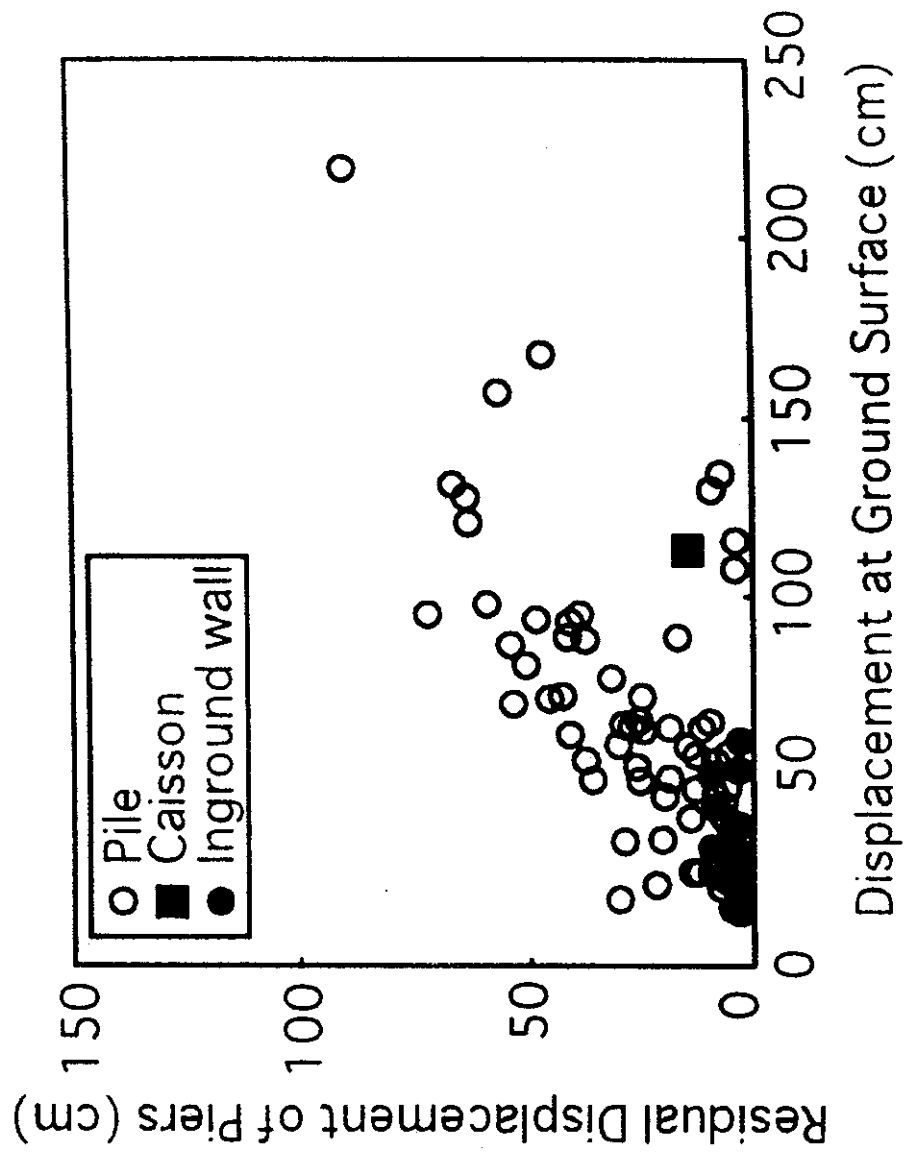
Fig. 3-6. Displacements of Bridge Piers Versus Displacements of Ground Surface
(Hamada and Wakamatsu 1996)

Hamada and Wakamatsu (1996) reported that the highway bridges of No. 5 Bay Highway in Uozaki-hama had in-ground-wall foundations. A comparison of lateral movements of bridge foundations versus the surrounding ground surface suggest that in-ground-walls and caissons were more effective than pile foundations in minimizing the permanent lateral deformations induced by liquefaction (Figure 3-6).

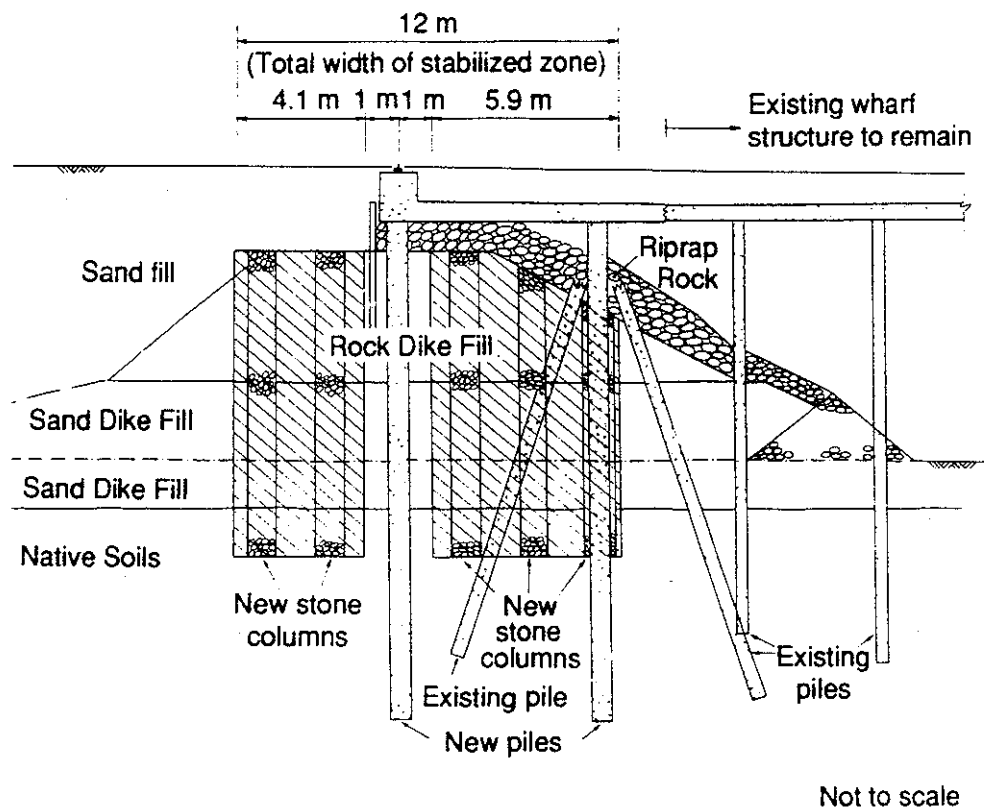
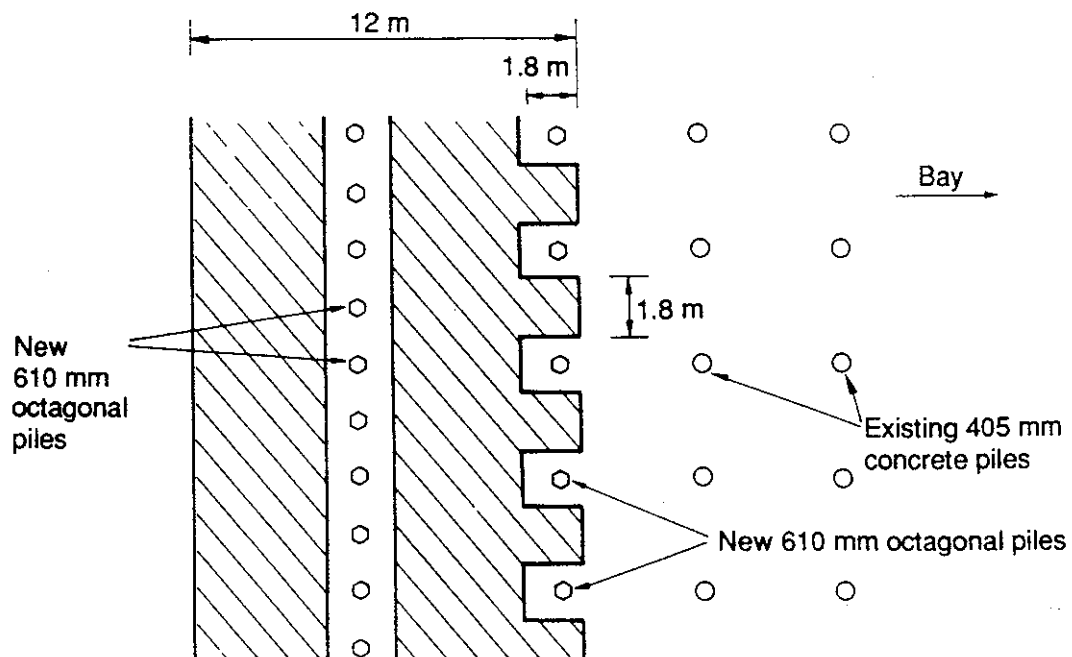
Fig. 4-2. Stone Column and New Piling Configuration for Seismic Repair at Seventh Street Marine Terminal (Egan et al. 1992)

Stone columns were used at the Seventh St. Marine Terminal at the Port of Oakland, after it was damaged in the Loma Prieta earthquake, to mitigate liquefaction hazards during future earthquakes (Egan et al. 1992). A 12-m wide zone of stone columns was constructed along the

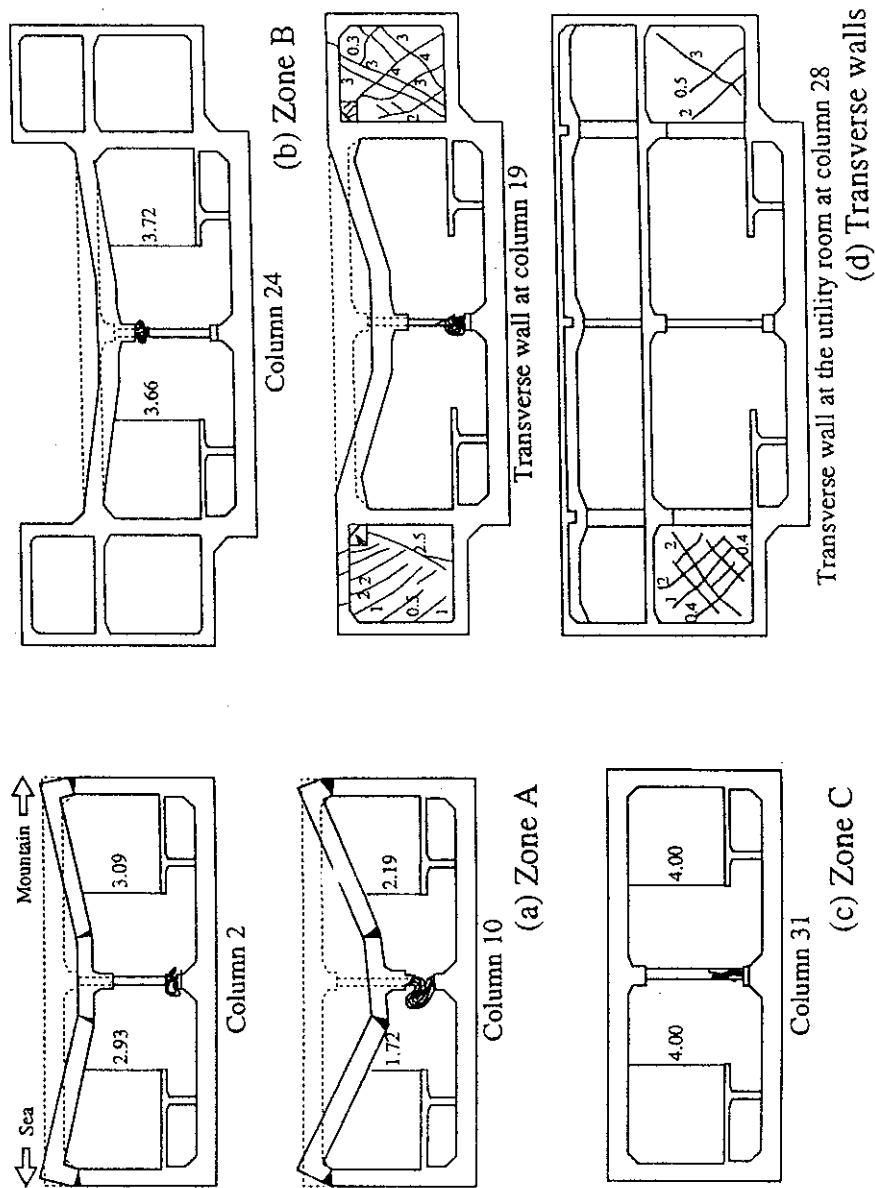
Fig. 5-1. Schematic of Damage Pattern in the Transverse Direction at the Daikai Subway Station (Nakamura et al. 1996)

The collapse of the Daikai subway station, a cut-and-cover underground metro station, in the 1995 Kobe earthquake was the first reported failure of an underground metro station during an earthquake (Iida et al. 1996, Matsuda et al. 1996, Nakamura et al. 1996). This 17 m wide, 7.2 m high, 120 m long box frame structure suffered complete collapse of more than half its center columns, followed by collapse of the ceiling slab (Figures 5-1 and 5-2). This structure was constructed in 1964 without consideration of seismic loads. Backfill around the structure was decomposed granite with corrected N-values of about 10 to depths of about 12 m. The water table was between depths of 6 and 8 m. Two-dimensional finite element analyses using equivalent-linear properties for the soil (Matsuda et al. 1996, Nakamura et al. 1996) suggest that the damage was primarily caused by strong horizontal forces due to relative displacements of the surrounding soils and inertial loads from the overburden soil during the earthquake. The presence of the loose backfill immediately adjacent to the structure was included in the analyses of Nakamura et al. (1996) but not in the analyses by Matsuda et al. (1996). The potential for liquefaction in the lower portions of the backfill, and the resulting influence on dynamic response, was not addressed in either analysis. Both analyses showed that the shear and bending capacity of the center columns was exceeded during the earthquake.

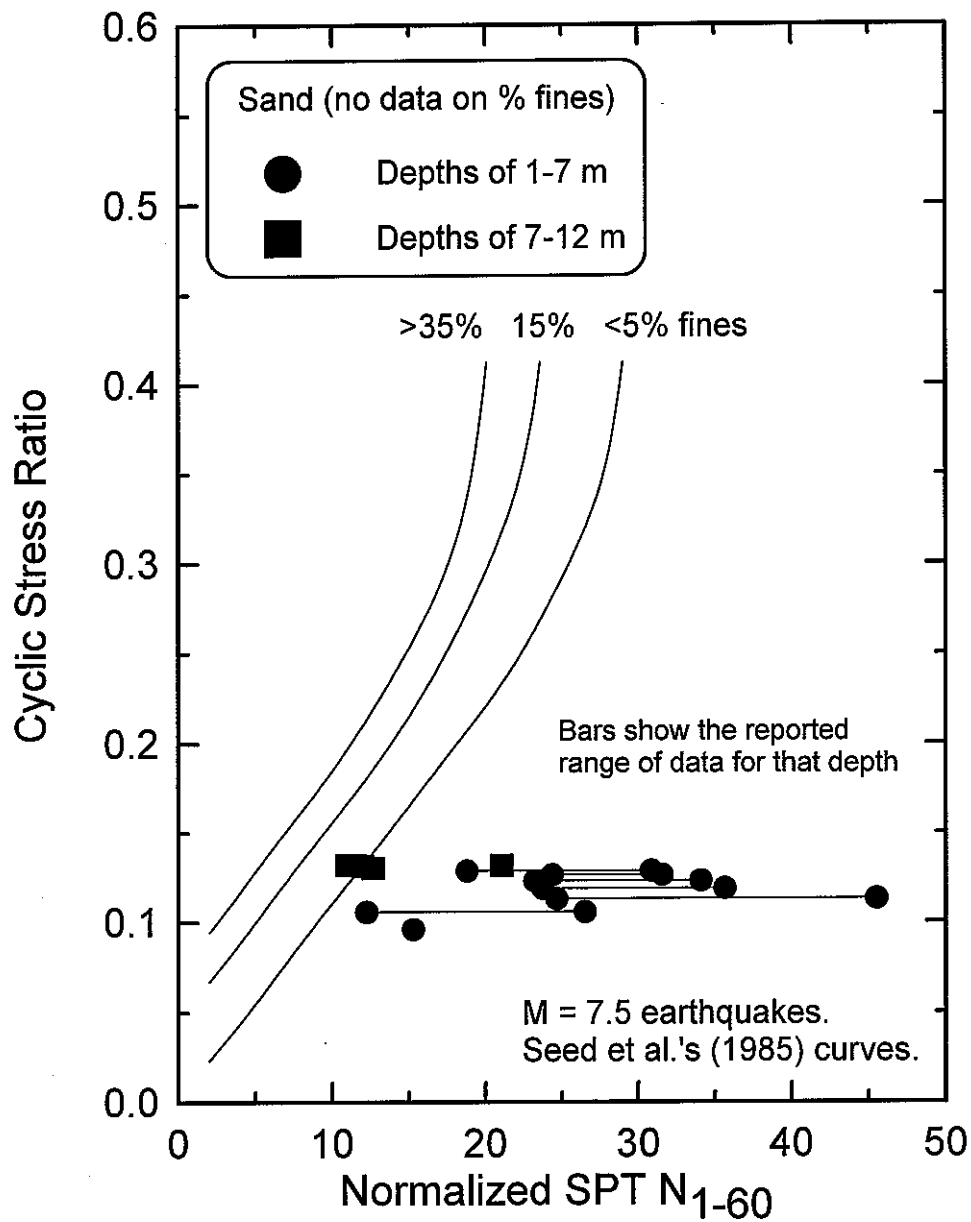
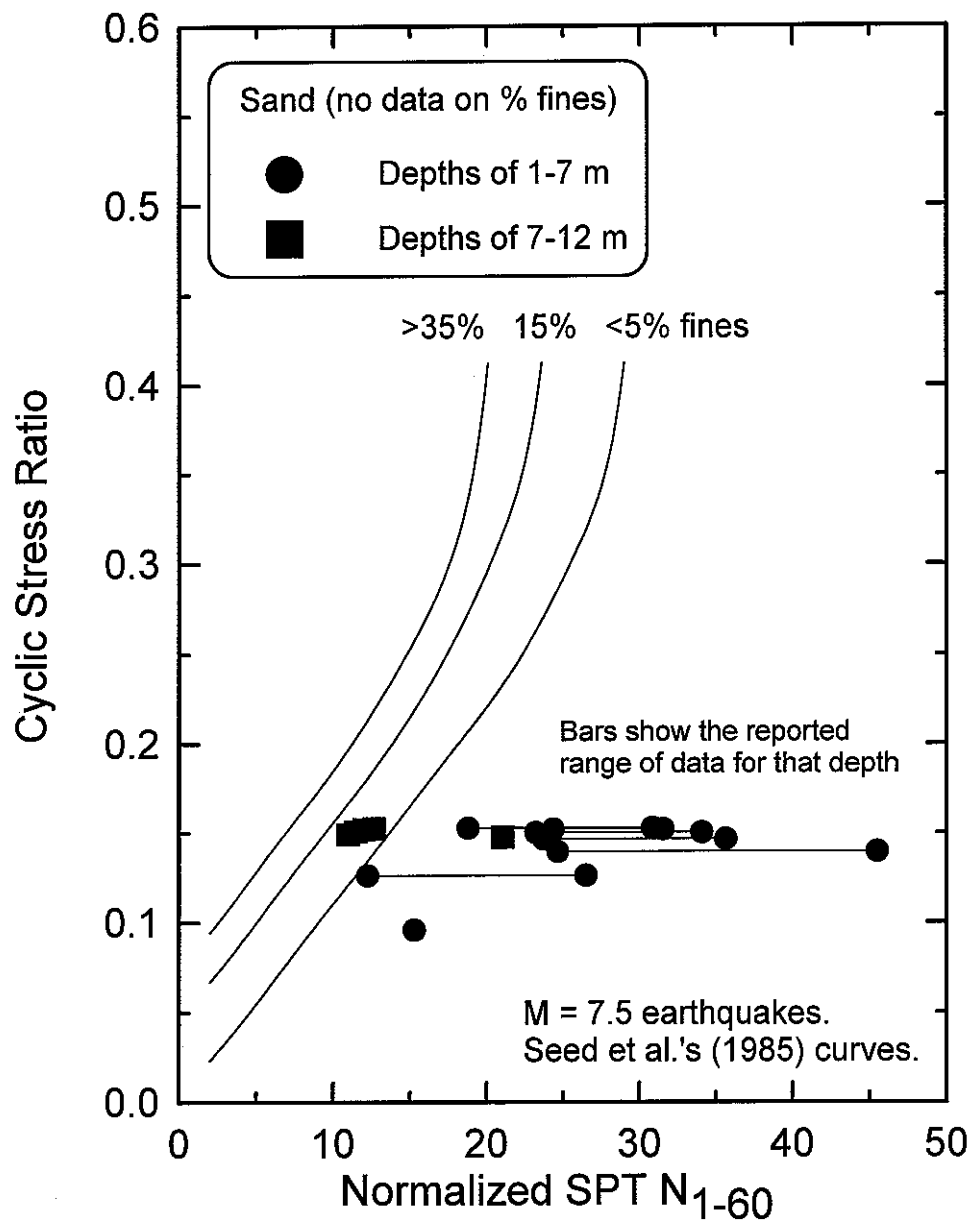
- (1) The 0.5 m of settlement experienced by the NTT Building (No. 2 in Table 2-1) is attributed to liquefaction between depths of 7 and 12 m. The treatment zone only extended to a depth of 7 m, and thus was of insufficient vertical extent to protect the building from damage.

Lessons learned	Large movements consistent with $FS_{liq} < 1$ and $N_{1-60}=8-14$ for 7-12 m depth. Treating the upper 7 m did improve the behavior relative to untreated areas, but not enough to prevent heavy damage. Note: post-earthquake borings in the treatment zone around the building gave N-values lower than from construction, and these lower N-values would give $FS_{liq} < 1$ in upper 2-7 m.

Fig. Liquefaction Analysis for the Four-Story NTT Building at Niigata: Including Weight of the Building in Calculating Cyclic Stress Ratios

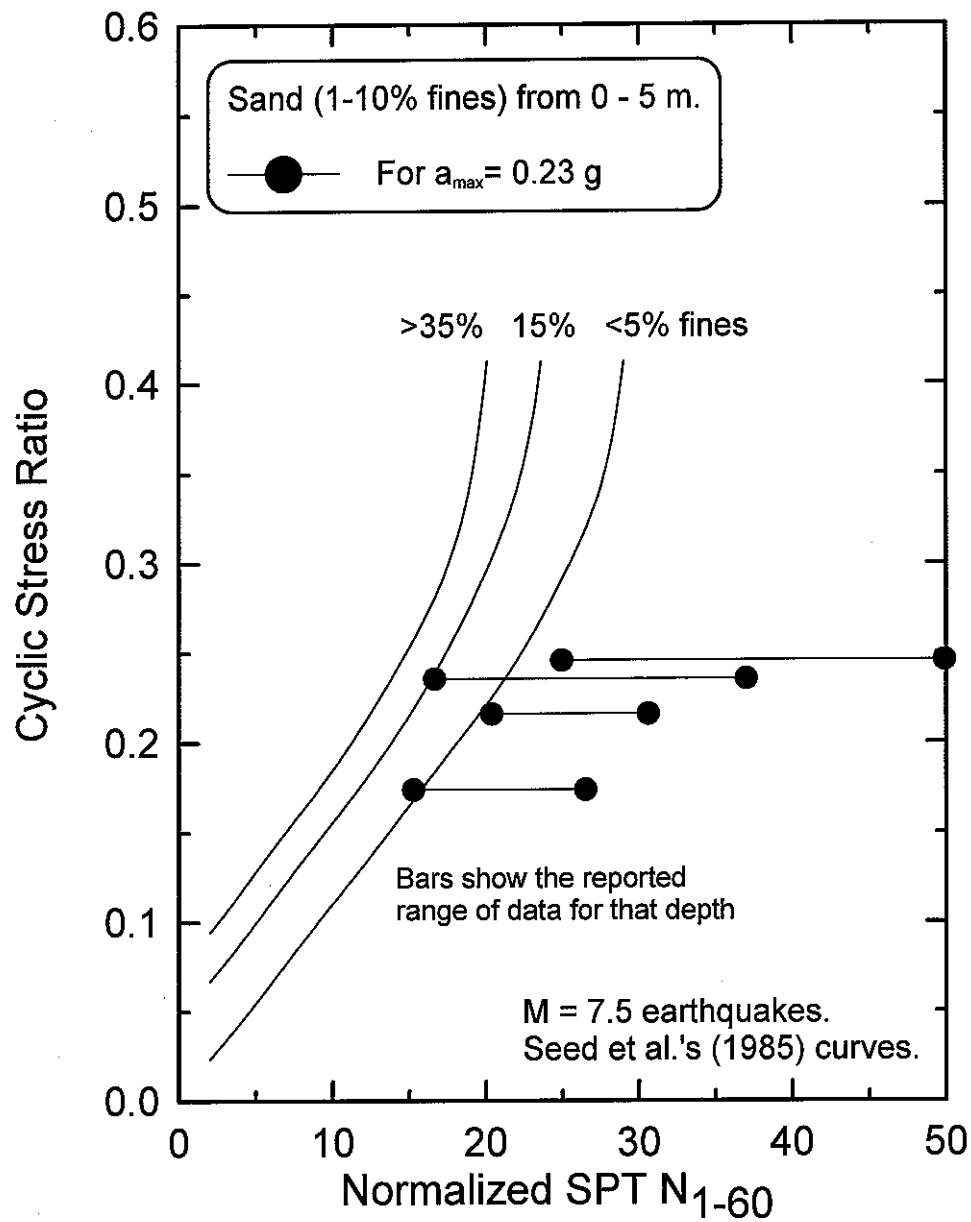
Untreated areas	Heavy damage, tilting of tanks, etc. Up to 500 mm offsets near nonliquefied zones.	
Insitu test data	Good summary plots of SPT and CPT data, but SPT procedures not described.	
Comments	The attached liquefaction analyses include no surcharge from the buildings. The range of N_{1-60} values for each depth interval represents the middle-two-thirds of the data points for that interval.	
Lessons learned	Treatment greatly improved behavior relative to untreated areas. Slab settlements <1.4 cm consistent with $FS_{liq} > 1$ over full depth except for at a very small fraction of SPT sampling points. Absence of visible damage to buildings in Group I may be partly due to use of piles. Treatment in strips under columns and footing beams did not prevent large movements.

Fig. Liquefaction Analysis for a Paper Plant in Hachinohe

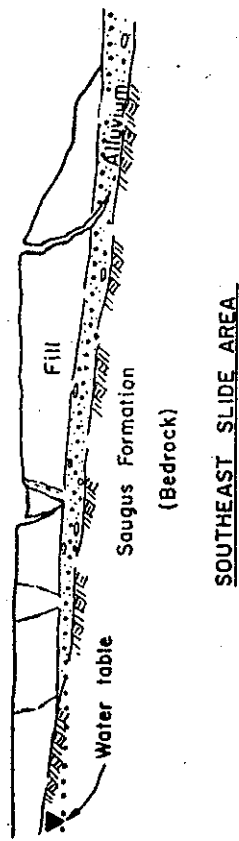
Lessons learned	Sand drain buttress did not prevent movements in treated area. Movements were less than experienced in 1971 San Fernando Earthquake. Poor performance is attributable to the high percentage of fines in the target layer which likely prohibited the dissipation of excess pore pressures during the earthquake.

SCHEMATIC CROSS-SECTION OF GROUND MOVEMENTS AT
JENSEN FILTRATION PLANT IN 1971 (Dixon and Burke 1977)

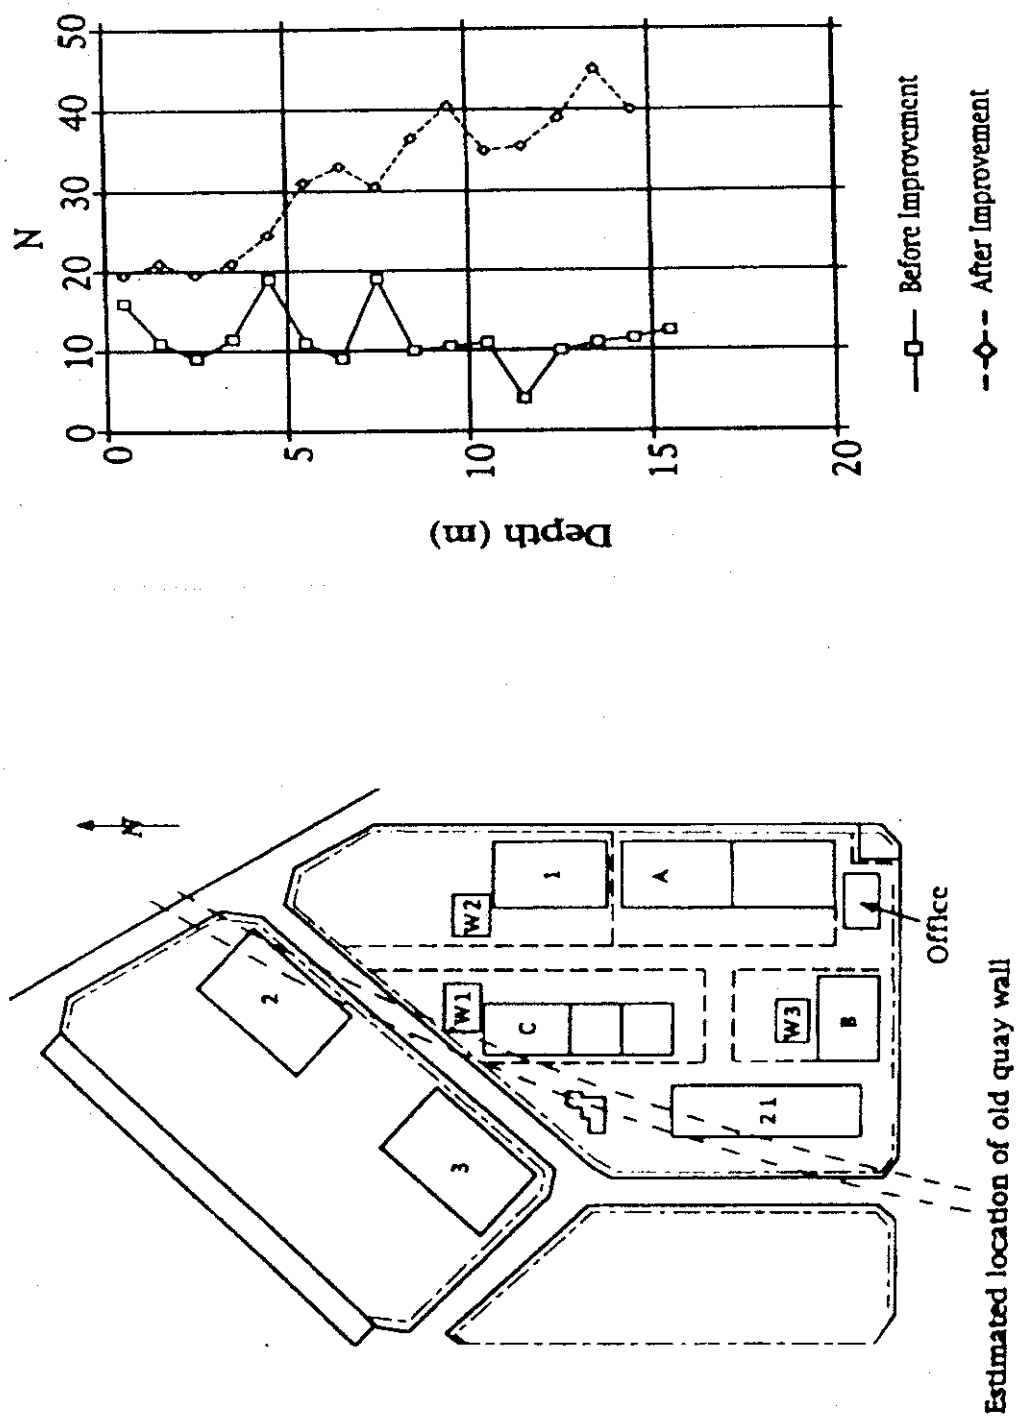
- (4) Damage to slabs within the "Warehouse Facility" on Port Island (Case 11 in Table 2-1) may be attributed to: (1) liquefaction of the surrounding soils between depths of 4 and 16 m since the treatment zones only extended 2-5 m beyond the building edges; and (2) liquefaction beneath portions of some warehouses since treatment may have been obstructed by a preexisting buried sea wall.

Untreated areas	Outside the facility: boils, cracks, and settlements up to 500 mm; warehouses on surrounding lots were badly damaged. In-between buildings: boils, and cracks to 100 mm.
Water table at 4 m depth.. 0-16 m: silty gravely sand (fill), 15-30% fines typ.	$N_{1-60}=9-14$ before, 34-40 after treatment. ^b
Insitu test data	1 SPT log before and after treatment.
Comments	Improvement may have been hindered under Warehouses C & 21 due to an old sea-wall; this needs to be clarified. The attached liquefaction analyses include no surcharge from the buildings.
Lessons learned	Treatment greatly improved behavior, and kept movements small enough to only damage the slabs in two of the five warehouses. Good behavior is consistent with the one SPT log showing $FS_{liq} \gg 1$ in the treated area. The slab damage may be due to the influence of the surrounding liquefied soils since the 2-5 m wide treatment zone beyond the building edges is only 0.1-0.3 times the thickness of the liquefiable fill.

Fig. Warehouse Facility on Port Island (EERC 1995)
