REPORT NO.
UCD/CGM-95/02

INVESTIGATION AND EVALUATION OF LIQUEFACTION RELATED GROUND DISPLACEMENTS AT MOSS LANDING DURING THE 1989 LOMA PRIETA EARTHQUAKE

Report No. UCD/CGM-95/02

May 1995

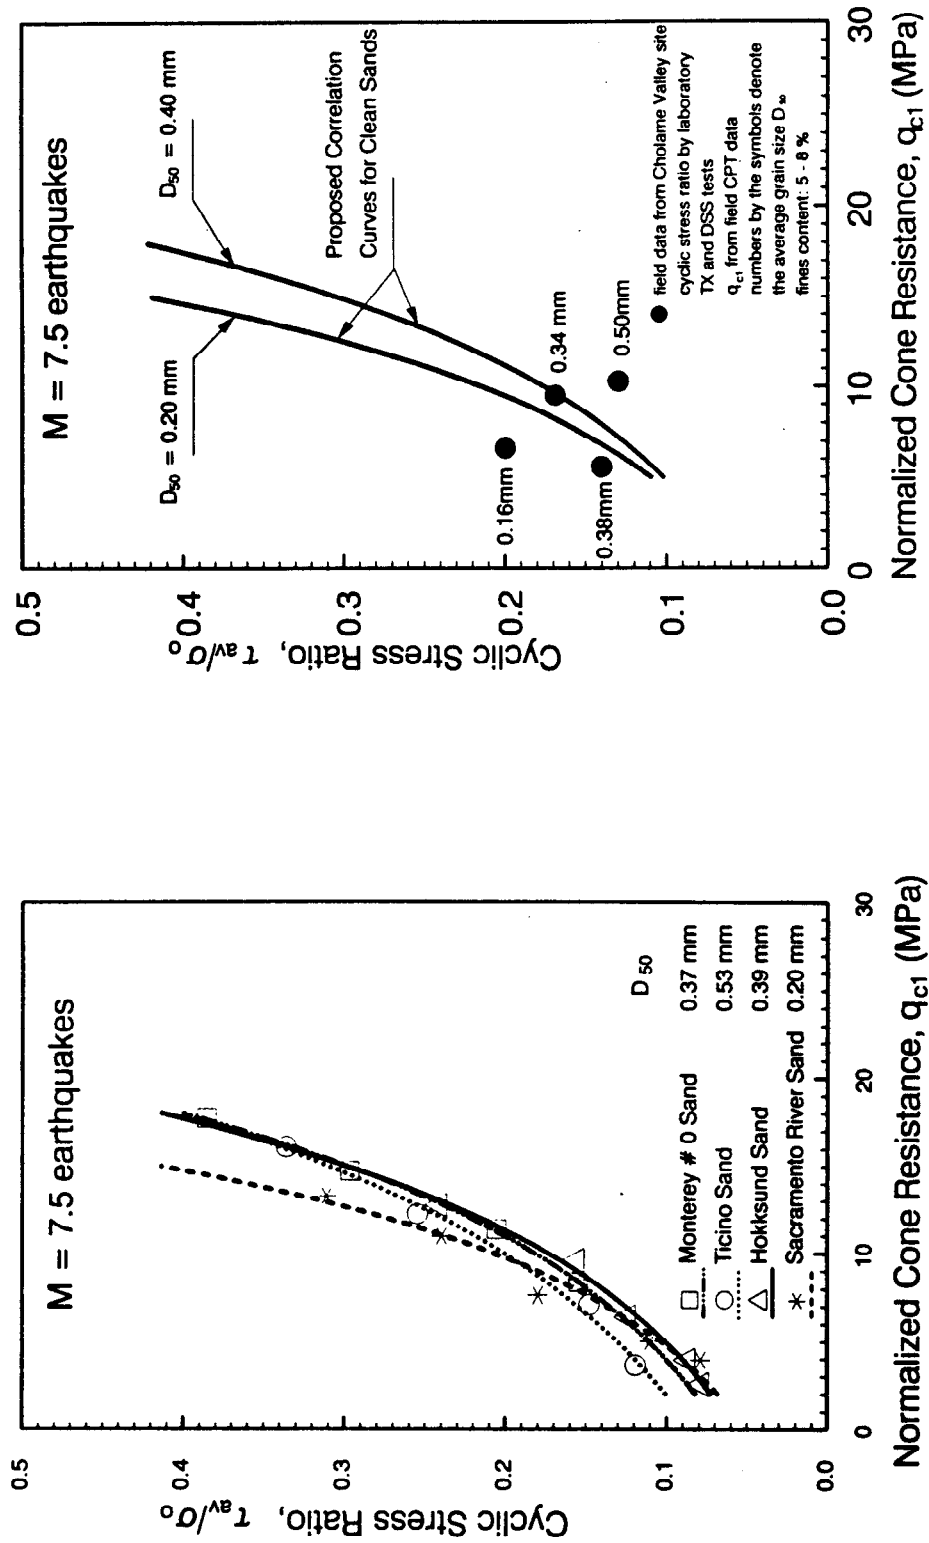
FIG. 1-5. Proposed Relationships Between Normalized CPT Tip Resistance and Cyclic Stress Ratio Required to Cause Liquefaction: Mitchell and Tseng (1990)

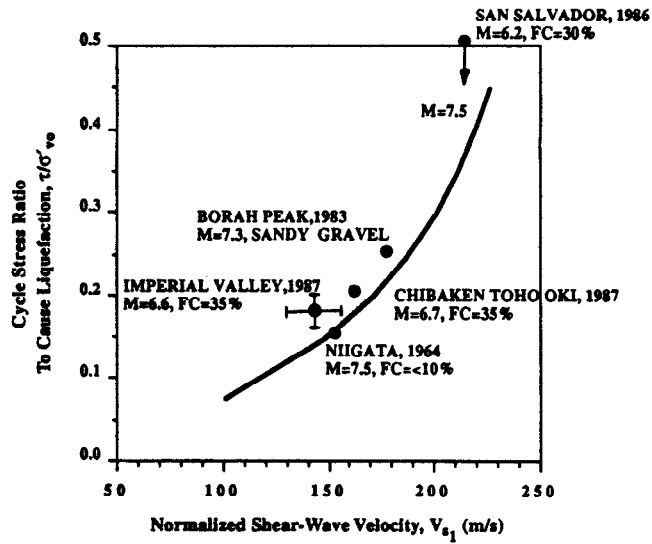
FIG. 1-6. Proposed Correlation Between Normalized Shear Wave Velocity and Cyclic Stress Ratio to Cause Liquefaction for $M=7.5$ Earthquakes (Robertson et al. 1992)

The critical value of V_{s-1} is 131 m/s at the entrance kiosk and 156 m/s at the beach pathway. Lower values of V_{s-1} at the entrance kiosk compared to those at the beach pathway are consistent with the larger liquefaction-induced deformations at the entrance kiosk. The induced cyclic stress ratios at the entrance kiosk and beach pathway are estimated to be about 0.19 and 0.24, respectively. These cyclic stress ratios are based on a peak ground acceleration of 0.25 g, and are adjusted to an equivalent $M=7.5$ earthquake based on the ratios presented by Seed and Idriss (1982). The above critical combinations of normalized shear wave velocity and earthquake-induced cyclic stress ratio are consistent with the relationship in Fig. 1-6 proposed by Robertson et al. (1992).

Subsequently, the V_{s-1} value of 167 m/s between depths of 3.1 and 4.1 m in CPT UC-12 is the only measurement that coincides fully with the sand-to-silty-sand layer suspected of liquefying. The induced cyclic stress ratios at this depth was estimated to be about 0.20, based on a peak ground acceleration of 0.25 g and after adjustment to an equivalent $M=7.5$ earthquake based on the ratios presented by Seed and Idriss (1982). This critical combination of normalized shear wave velocity and earthquake-induced cyclic stress ratio is consistent with the relationship in Fig. 1-6 proposed by Robertson et al. (1992).

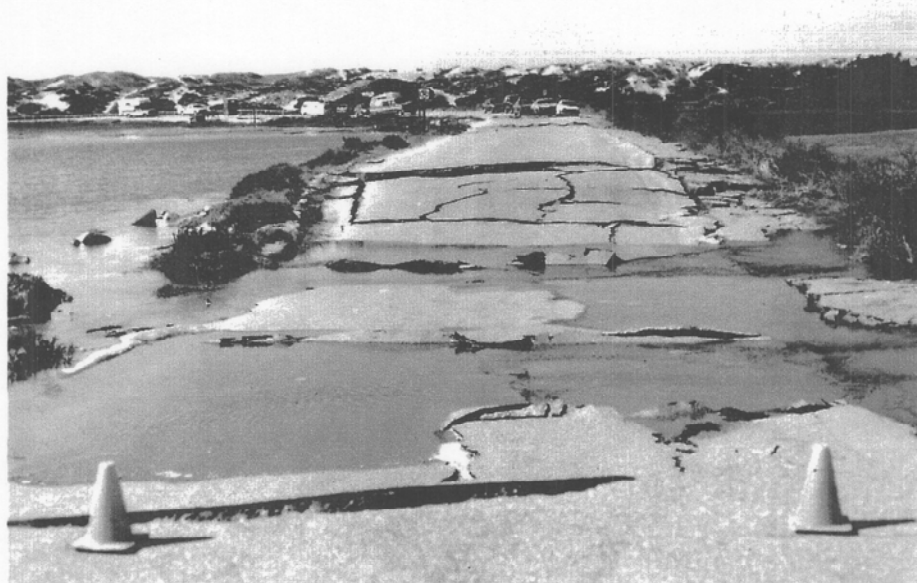
FIG. 5-2(a). Collapse of the Tide Gate Across Jetty Road to Moss Landing State Beach
(Note: the Entrance Kiosk is visible in the distance).

Liquefaction-induced lateral spreading caused extensive damage to the access road, particularly between the tide gate to Bennett Slough and the pathway to the beach. The tide gate was destroyed because of a liquefaction flow slide that resulted in the road surface slumping about 1.3 m across the full tide gate span (Fig. 5-2a). Tidal water movements subsequently eroded the slide debris.

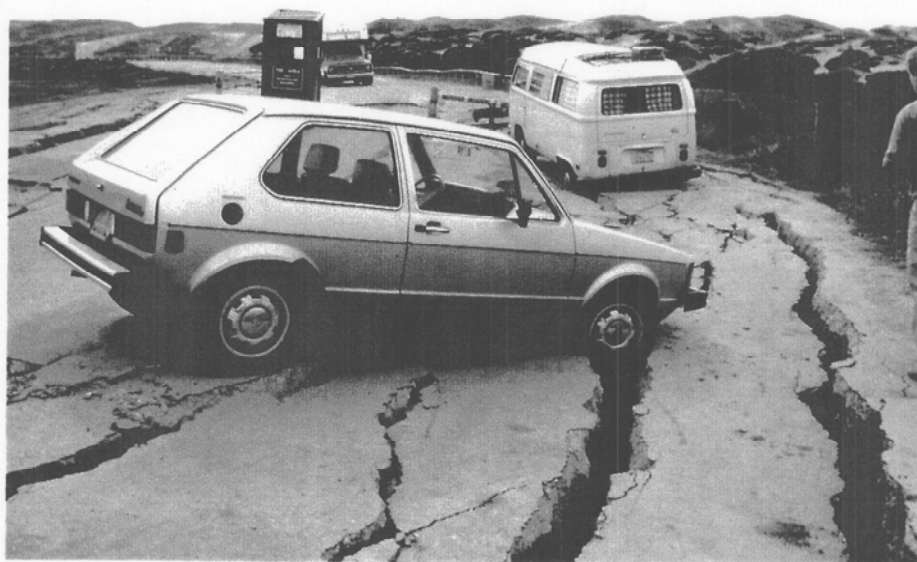
FIG. 5-2(b). Entrance Kiosk at Moss Landing State Beach.

At the entrance kiosk, deformations due to lateral spreading were roughly 0.3 to 0.6 m horizontal with vertical offsets of up to 0.3 m (Fig. 5-2b). Near the entrance to the beach pathway, lateral spreading deformations were about 0.1 to 0.3 m horizontal with vertical offsets of up to 0.05 to 0.10 m (Fig. 5-3). On the tidal flats on the north side of the access road, sand boils occurred at several locations and a series of ground cracks extended along the tide flat near the base of the dunes. About 130 m south of the beach pathway entrance, visible evidence of ground deformations essentially ceased. The above estimates of ground deformations are based on photographs of the site (Gray 1993; Harder 1993; Kutter 1993) and by the field notes of Tinsley (1993).

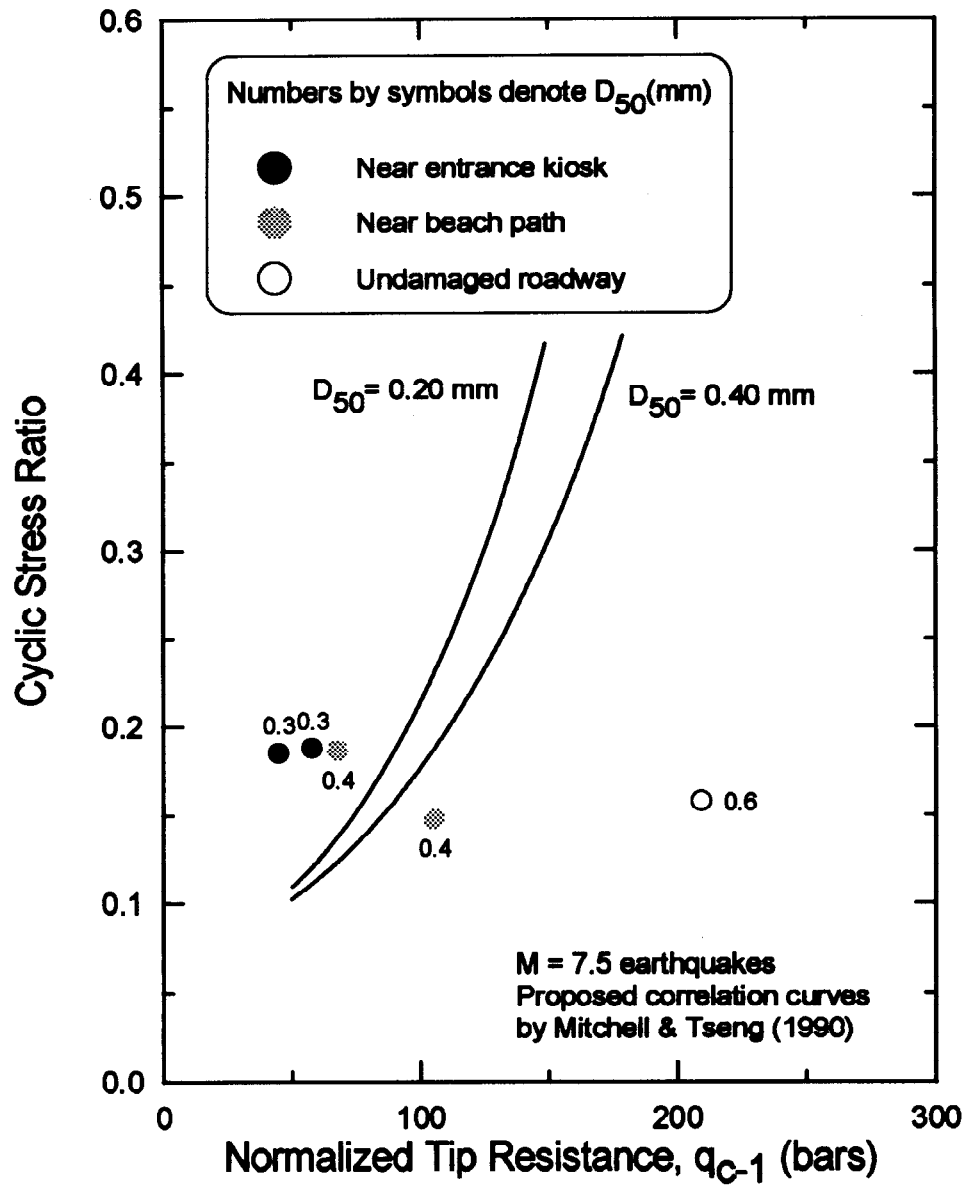
FIG. 5-7. Correlation of CPT Tip Resistance to Liquefaction Resistance at the Moss Landing State Beach

to equivalent cyclic stress ratios for $M=7.5$ earthquakes based on the ratios presented by Seed and Idriss (1982). For reference purposes, Fig. 5-7 also shows the boundary between conditions of liquefaction and non-liquefaction proposed by Mitchell and Tseng (1990) for clean sands with D_{50} equal to 0.20 mm and 0.40 mm. The boundaries proposed by Mitchell and Tseng (1990) are generally consistent with the observed behavior at this site, except for one point (CPT UC-16) near the beach path which is slightly outside the proposed boundary for a clean sand with a D_{50} of 0.40 mm.

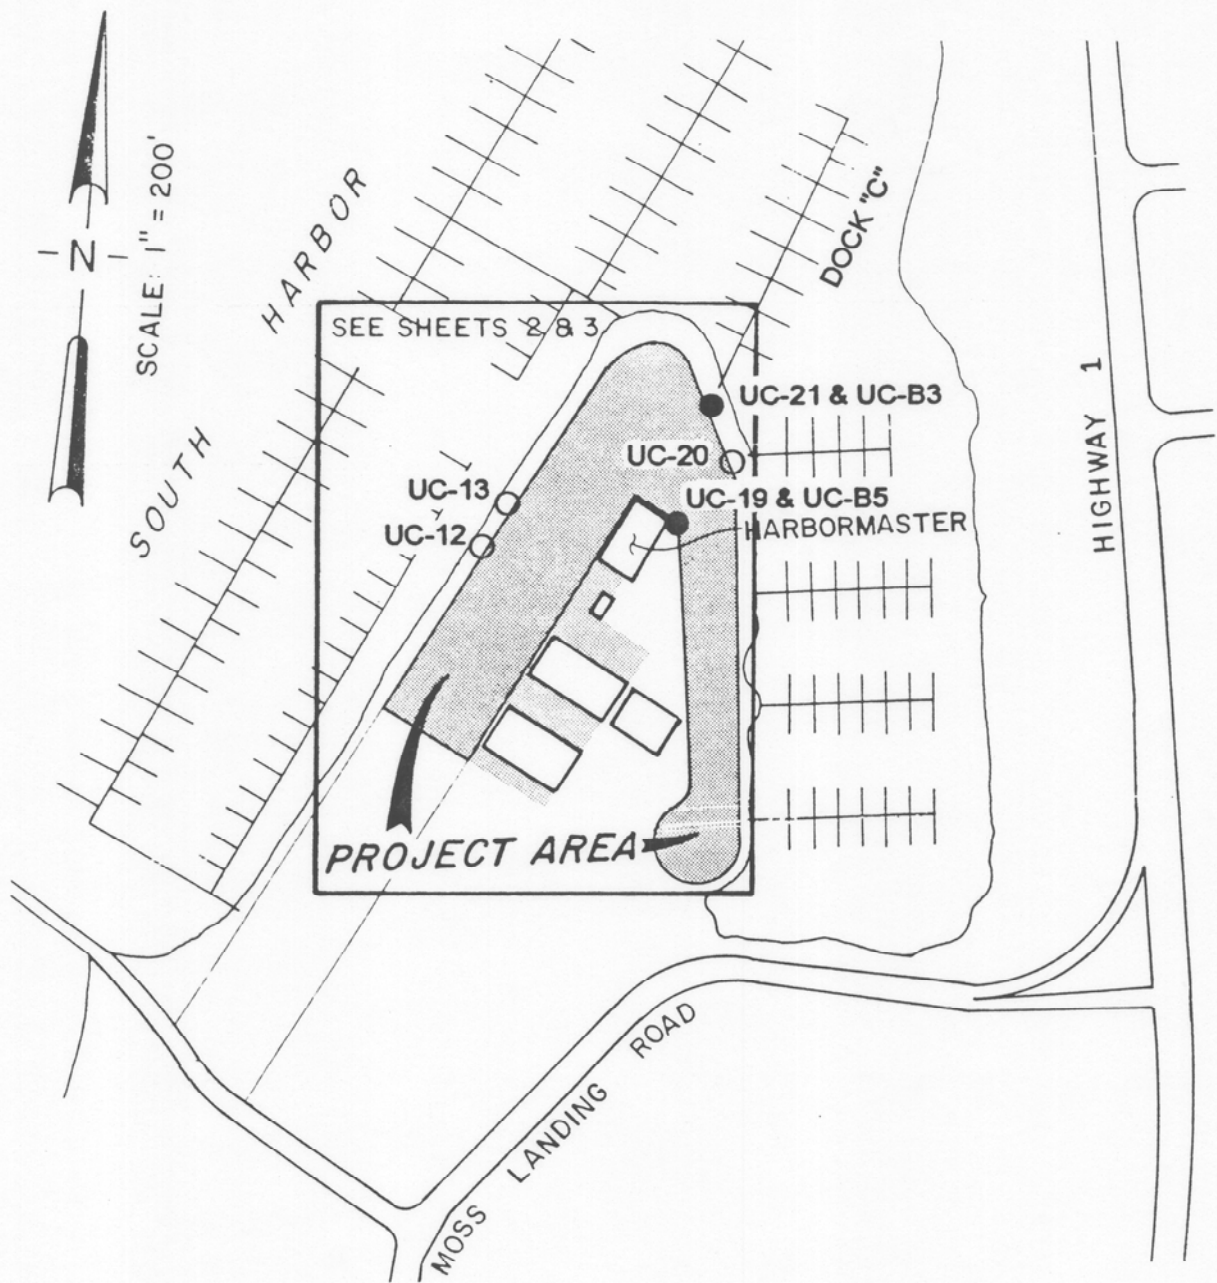
Locations are approximate only.

- CPT sounding and SPT boring
- CPT sounding

Five cone penetration test (CPT) soundings and two rotary wash borings were performed at the locations shown on Fig. 5-1. Two CPT soundings (UC-15 and UC-16) included shear wave velocity measurements. Appendix A contains the logs of the CPT soundings which were performed on August 19th, 1994. Appendix B contains the logs of the borings which were performed on August 17th and 18th, 1994. Appendix C contains the results of grain size analyses and Atterberg Limit tests.

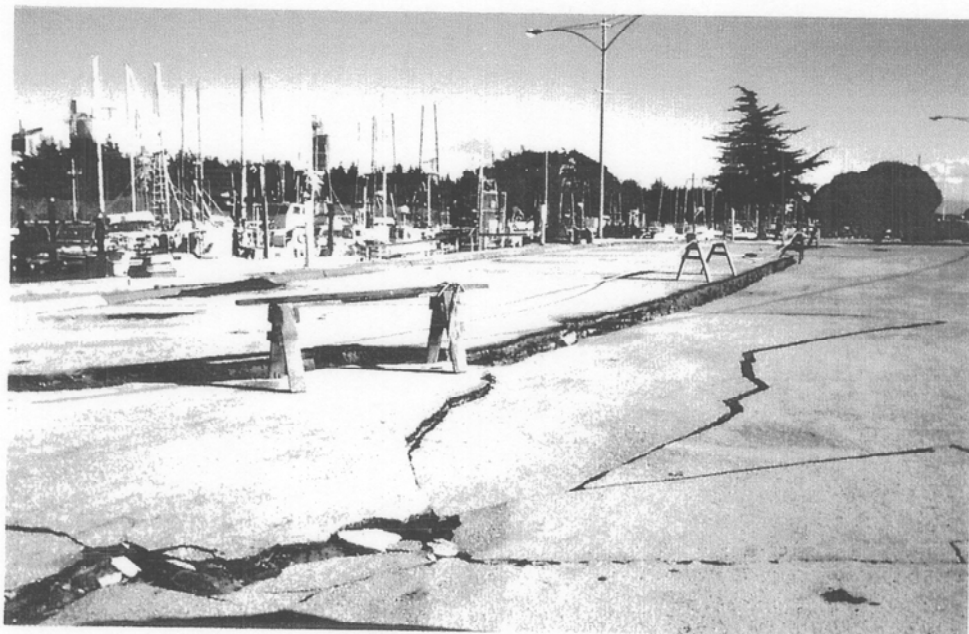
FIG. 6-3. Cracking at North End of Parking Lot Near Dock "C."

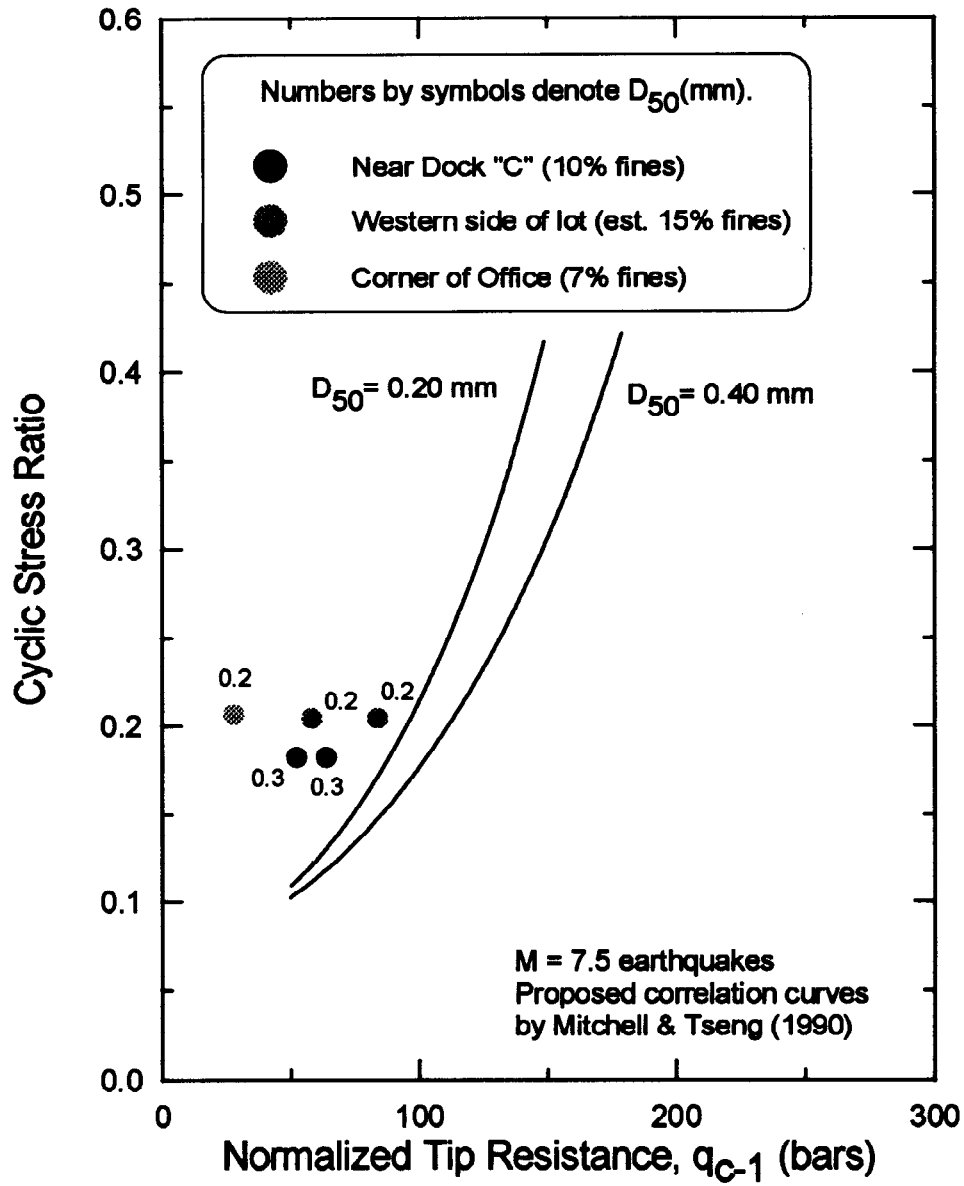
FIG. 6-7. Correlation of CPT Tip Resistance to Liquefaction Resistance at the Moss Landing Harbor Office

Critical combinations of earthquake-induced cyclic stress ratio and normalized CPT tip resistance are shown in Fig. 6-7. Critical CPT tip resistances were estimated using the guidelines previously described in Section 1.3. Cyclic stress ratios are adjusted to equivalent cyclic stress ratios for $M=7.5$ earthquakes based on the ratios presented by Seed and Idriss (1982). The field evidence, particularly the sand boils, indicates that liquefaction likely occurred in the sand to sandy silt layer between depths of about 3.0 to 6.8 m along the edges of the spit (Dock "C" and the western edge of the parking lot). At the northeast corner of the office, the most critical depth was taken as the thin silty sand layer at a depth of about 7.1 m. For reference purposes, Fig. 6-7 also shows the boundary between conditions of liquefaction and non-liquefaction proposed by Mitchell and Tseng (1990) for clean sands with D_{50} values of 0.20 mm and 0.40 mm. The boundaries proposed by Mitchell and Tseng (1990) are consistent with the observed behavior at these two locations. In addition, the CPT tip resistances are lower near Dock "C" than near the western side of the parking lot, which is consistent with the observed deformations being larger near Dock "C;" no comparison is made with the northeast corner of the office where deformations were smallest because of the different distances to a free face.

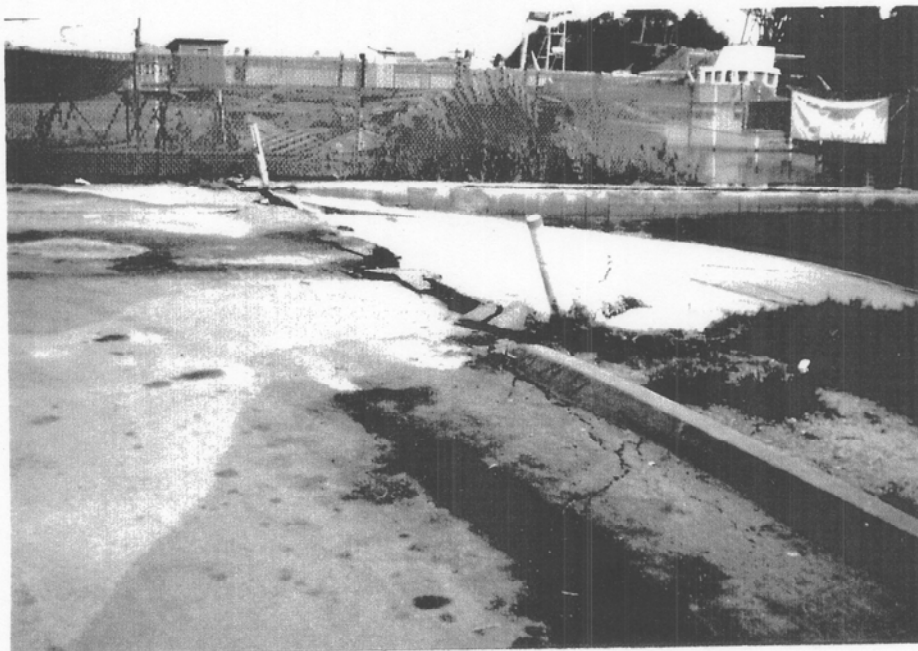
FIG. 7-2. Cracking and Settlement of the Boat Launch at Woodward Marine.

Liquefaction-induced ground spreading was evident across much of the site. Along the shoreline, the Chevron sign and supporting pile toppled over onto the fuel dock, jetty piles were displaced horizontally, and the boat ramp and adjacent asphalt pavement experienced cracking and settlement (Fig. 7-2). A long crack, having offsets up to about 5 cm vertical and 2 cm horizontal, and located roughly 8 to 12 m back from (and parallel to) the shoreline, developed in the asphalt pavement extending from the Woodward Marine office to the boat launch ramp. The Woodward Marine office building fell off its foundation, and compression buckling was observed in the masonry brick patio surface at the building entrance. Several cracks, roughly sub-parallel to the shoreline, traversed in the asphalt pavement (Salmon Way) connecting the boat launch ramp to Sandholdt Road, with the larger cracks having horizontal displacements of up to about 5 cm. The Chevron oil and gas tanks, located on the southern side of Salmon Way at its junction with Sandholdt Road, settled and tilted between 1 and 6 degrees from vertical (Tuttle et al. 1990). Fig. 7-3 shows a view of the tilted tanks and the accumulation of vented sand around their foundations. Gray, coarse- to medium-grained sand was vented through some of the 5- to 50-mm-wide cracks near the tanks (Tuttle et al. 1990). It was also noted that the vented sand occurred mostly toward the northern side of the tanks, while little or no sand vented on the southern side of the tanks (Tuttle et al. 1990). Sand dikes were traced from the ground surface to a depth of about 0.8 m through a gravelly sand and gray, medium-grained sand to a gray, silty sand (Tuttle et al. 1990).

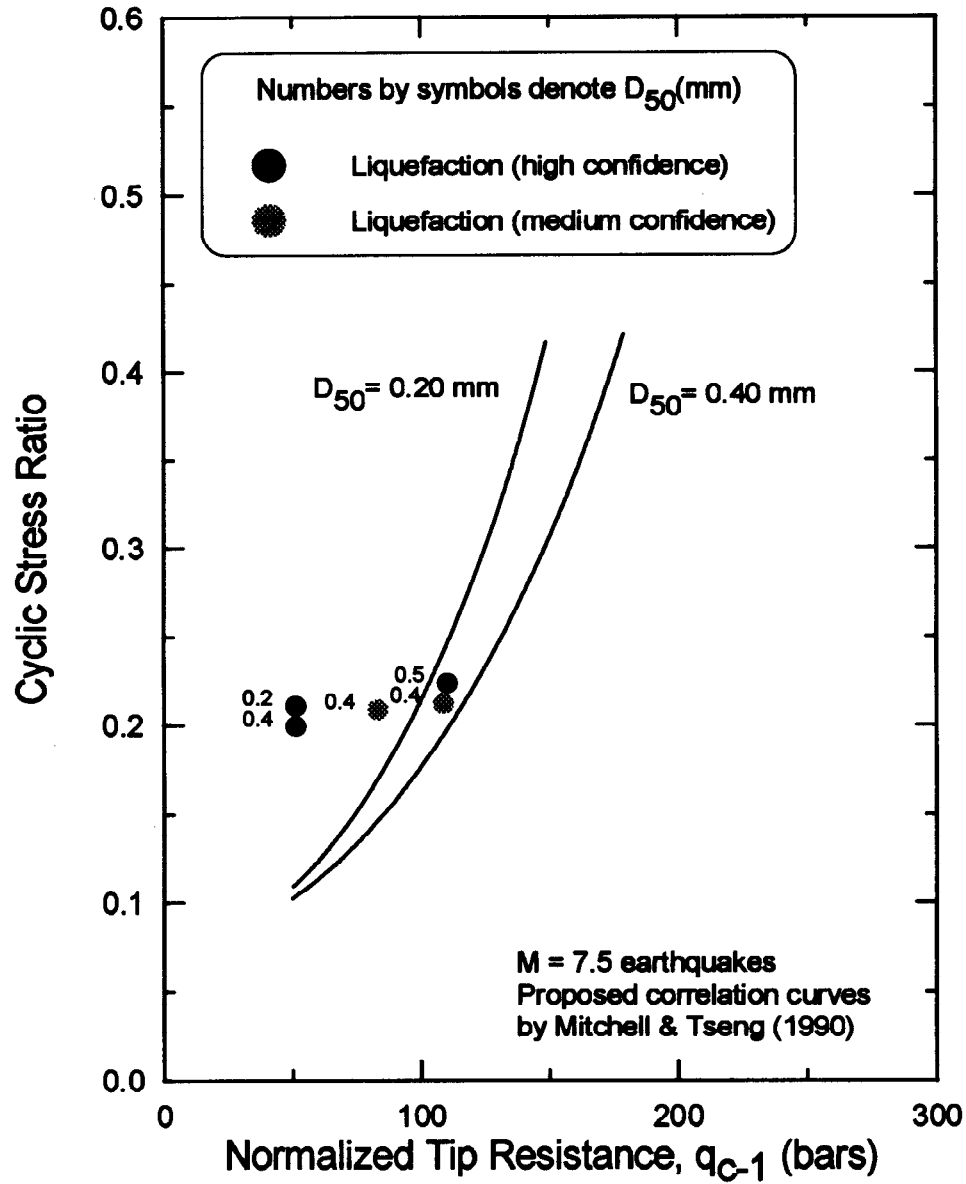
FIG. 7-7. Correlation of CPT Tip Resistance to Liquefaction Resistance at Woodward Marine

Critical combinations of earthquake-induced cyclic stress ratio and normalized CPT tip resistance for each of the CPT soundings are shown in Fig. 7-7. Critical CPT tip resistances were estimated using the guidelines previously described in Section 1.3. Cyclic stress ratios are adjusted to equivalent cyclic stress ratios for $M=7.5$ earthquakes based on the ratios presented by Seed and Idriss (1982). Along the eastern end of Salmon Way (CPTs UC-10 and UC-11), the critical depths were taken in the silty sand and sand layer between depths of about 1.7 and 3.4 m. This sand layer was also considered critical near the Chevron fuel tank enclosure, as evidenced by the sand ejecta within the fuel tank enclosure. On the south side of the fuel tanks (USGS-14A, Fig. 7-5), the critical sand layer extended from the surface fill down to the underlying dense sands and the critical normalized CPT tip resistance was 110 bars at a depth of 3.6 m. On the north side of the fuel tanks (UC-9 and USGS-15A; Figs. 7-4 and 7-5), characterization of the critical sand layer is difficult because the layer becomes relatively thin and is sandwiched between the overlying soft sandy silt and the underlying dense sands. In both UC-9 and USGS-15A, the normalized CPT tip resistance in the critical sand layer increased gradually from about 5 bars at the contact with the soft sandy silt to about 140-150 bars at 0.4 m below the contact, and then stayed relatively constant over the next 0.4 m. The gradual transition in CPT tip resistances is thought to reflect a real transition in soil characteristics because the transition interval is relatively thick and similar gradual transitions in CPT tip resistance are seen elsewhere at Woodward Marine where the soft sandy silt layer is not encountered. Subsequently, the critical normalized CPT tip resistances for CPTs UC-9 and USGS-15A were taken over a 0.3 m interval beginning 0.15 m below the contact with the soft sandy silt, resulting in values of about 105 and 81 bars, respectively. While these values are quite sensitive to the interval thickness over which the tip resistance is averaged, the 0.3 m interval used herein resulted in values reasonably close to the critical value of 116 bars obtained from USGS-14A. Given the subjectiveness of the critical tip resistances for CPTs UC-9 and USGS-15A, these data points are labelled as "medium-confidence" in Fig. 7-7. For reference, Fig. 7-7 also shows the boundary between conditions of liquefaction and non-liquefaction proposed by Mitchell and Tseng (1990) for clean sands with D_{50} values of 0.20 mm and 0.40 mm. The boundaries proposed by Mitchell and

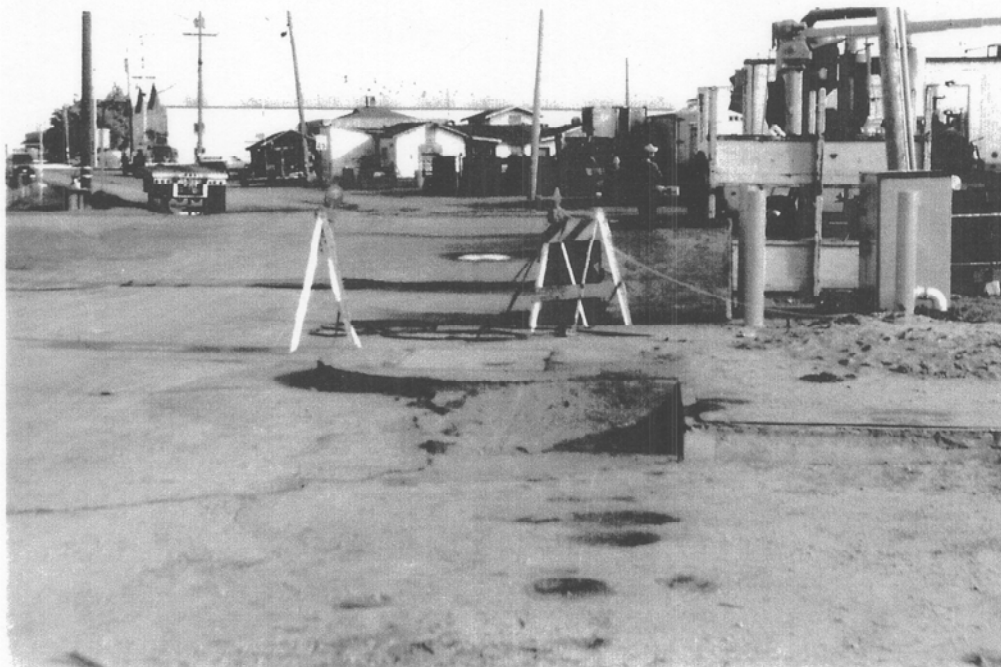
FIG. 8-2(a). Differential Settlement at a Sewer Well on Sandholdt Road, Just to the North of the MBARI Pier (looking north).

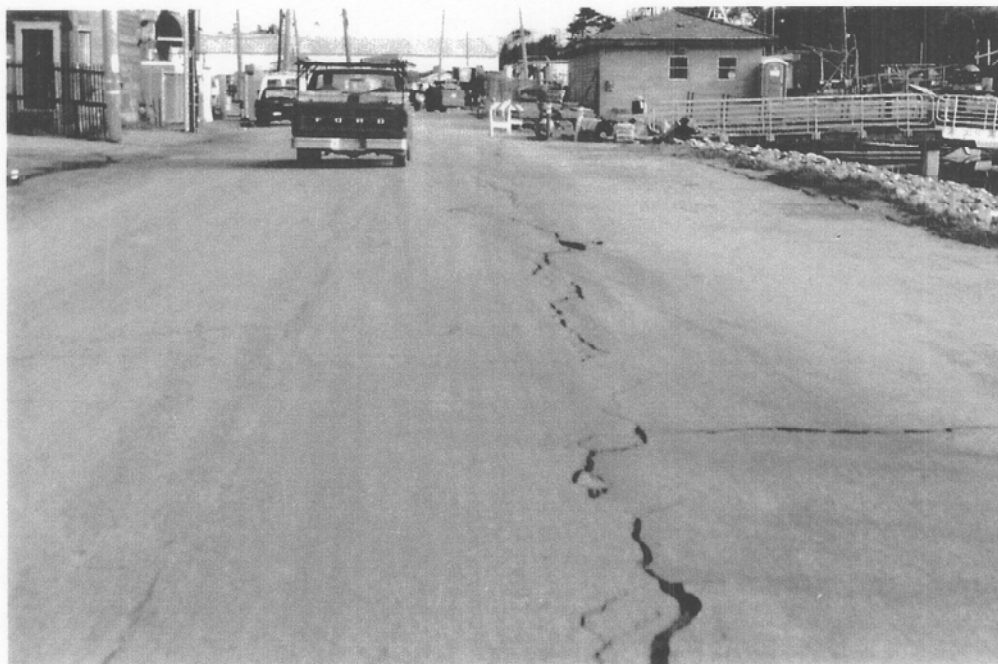
FIG. 8-2(b). Cracking Along Sandholdt Road Just to the South of the MBARI Pier (looking north).

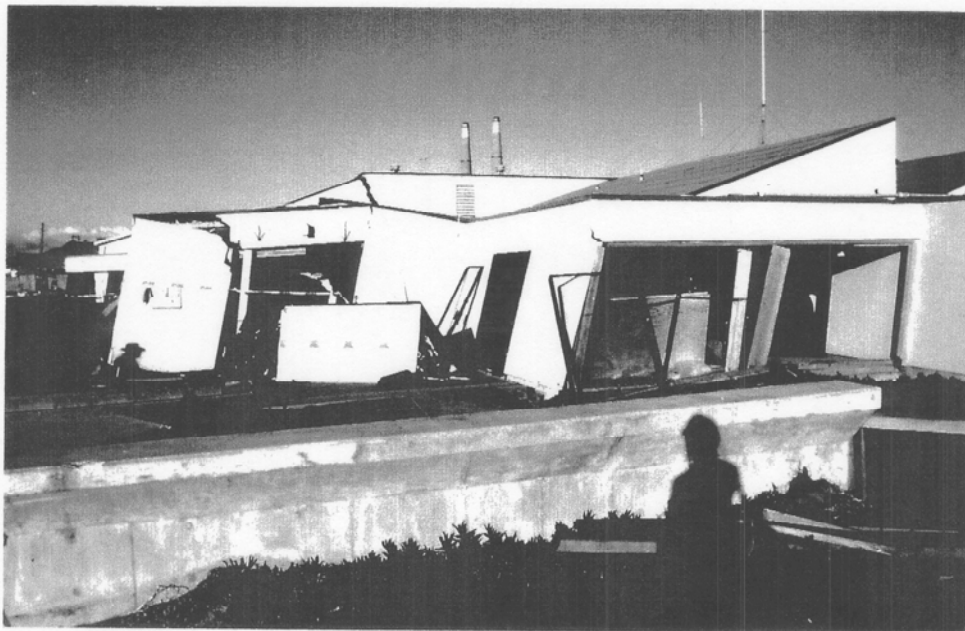
FIG. 9-2(a). Racking of Director's Office at Southwest Corner of MLML.

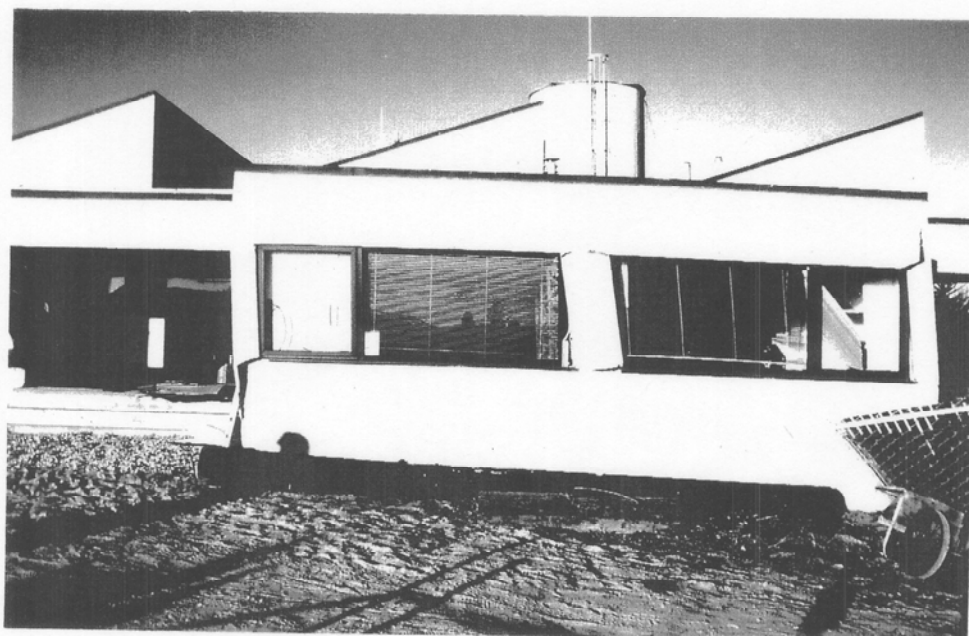
FIG. 9-2(b). Racking of Southern Building at Southeast Corner of MLML.

The MLML facilities were damaged beyond repair by liquefaction-induced lateral spreading and differential settlement of the site. Although the structures were practically torn apart at the foundation, the structures did not collapse and no severe injuries occurred to the approximately 50 people reportedly occupying the building at the time. The level of damage sustained is illustrated in Figs. 9-2(a) and 9-2(b), which show racking of the southeast and southwest corners of the laboratory, respectively.

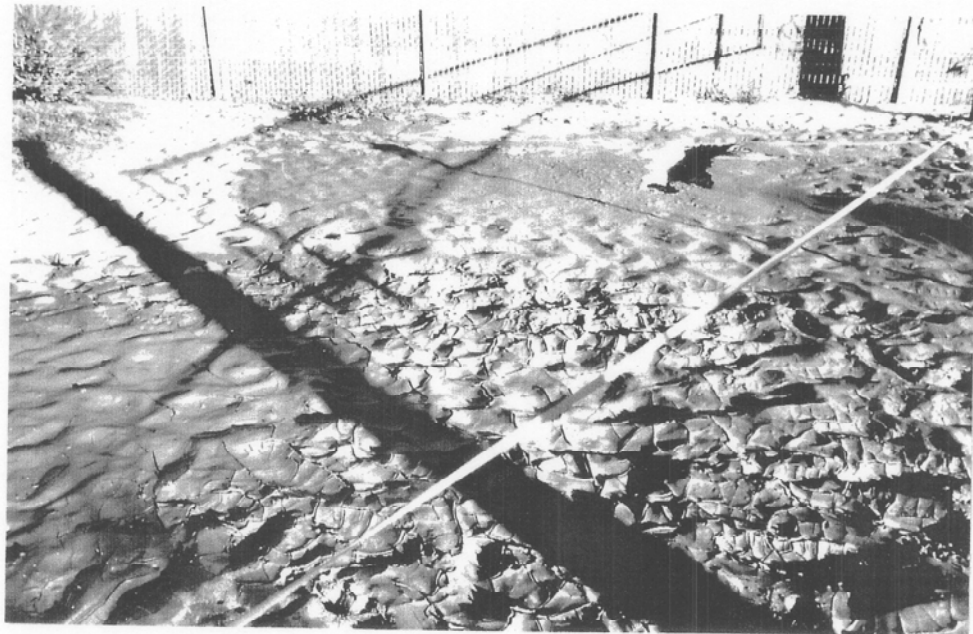
FIG. 9-4. Soil Boil Ejecta in Volley Ball Court.
