**REPORT NO.
UCD/CGM-97/03**

GROUND IMPROVEMENT ISSUES FOR THE POSEY & WEBSTER ST. TUBES SEISMIC RETROFIT PROJECT: LESSONS FROM CASE HISTORIES

APRIL 1997

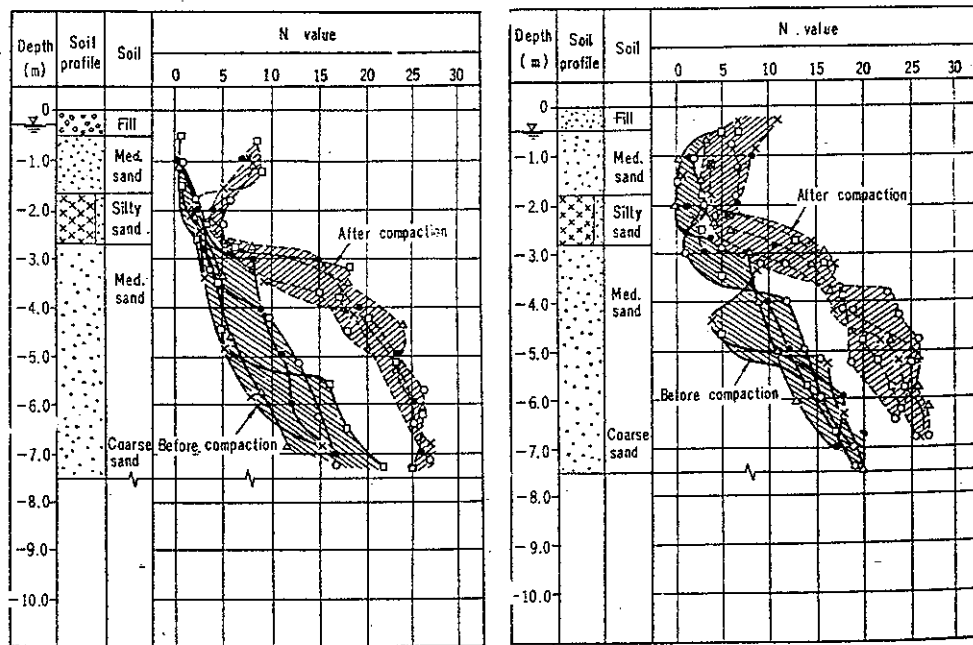
Fig. Oil Tanks at the Nippon Oil Co. in Niigata (Watanabe 1966)

Insitu test data	Good summary plots of SPT data, but SPT procedures not described.	
Comments	Why did N values increase between 5-7 m deep when treatment was only to 5-6 m deep? The attached liquefaction analyses used either: (i) no surcharge from a tank, or (ii) a 120 kpa surcharge assumed to be constant over the depth of interest. The range of N_{1-60} values for each depth interval represents the middle-two-thirds of the data points for that interval.	
Lessons learned	Treatment was effective in reducing settlements to harmless levels (<2 to 3 cm). Small settlements consistent with a FS_{liq} close to 1.0 in pockets of upper 3 m.

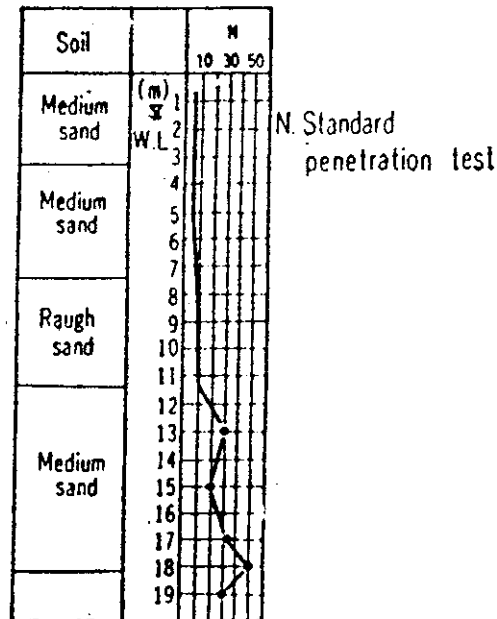
Table 3. Comparison of standard penetration tests before and after compaction (Niigata Telecommunications Division Building)

Lessons learned	Large movements consistent with $FS_{liq} < 1$ and $N_{1-60}=8-14$ for 7-12 m depth. Treating the upper 7 m did improve the behavior relative to untreated areas, but not enough to prevent heavy damage. Note: post-earthquake borings in the treatment zone around the building gave N-values lower than from construction, and these lower N-values would give $FS_{liq} < 1$ in upper 2-7 m.

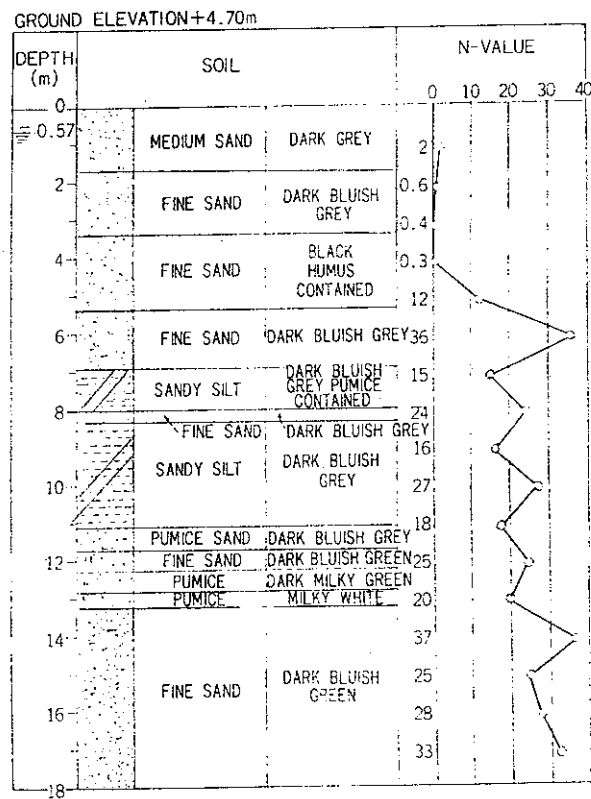
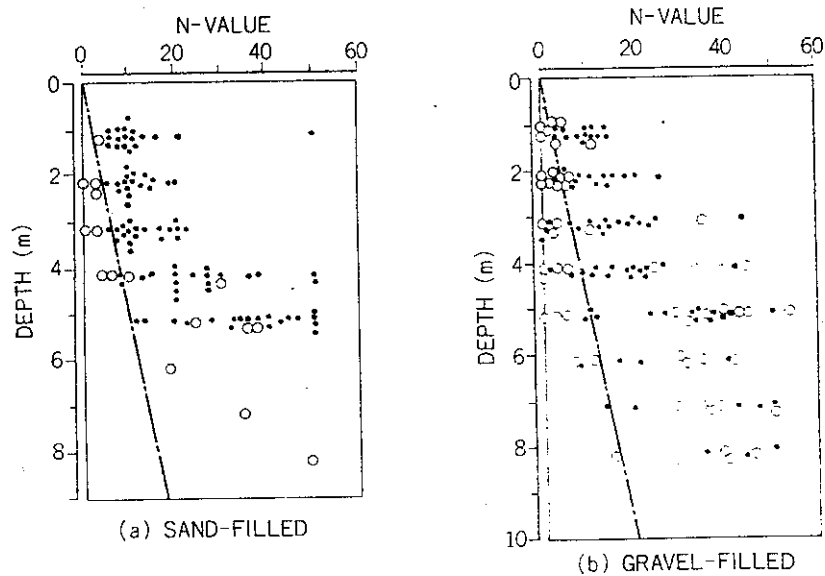
Fig. Paper Plant in Hachinohe (Ohsaki 1970)

Untreated areas	Heavy damage, tilting of tanks, etc. Up to 500 mm offsets near nonliquefied zones.	
Insitu test data	Good summary plots of SPT and CPT data, but SPT procedures not described.	
Comments	The attached liquefaction analyses include no surcharge from the buildings. The range of N_{1-60} values for each depth interval represents the middle-two-thirds of the data points for that interval.	
Lessons learned	Treatment greatly improved behavior relative to untreated areas. Slab settlements <1.4 cm consistent with $FS_{liq} > 1$ over full depth except for at a very small fraction of SPT sampling points. Absence of visible damage to buildings in Group I may be partly due to use of piles. Treatment in strips under columns and footing beams did not prevent large movements.

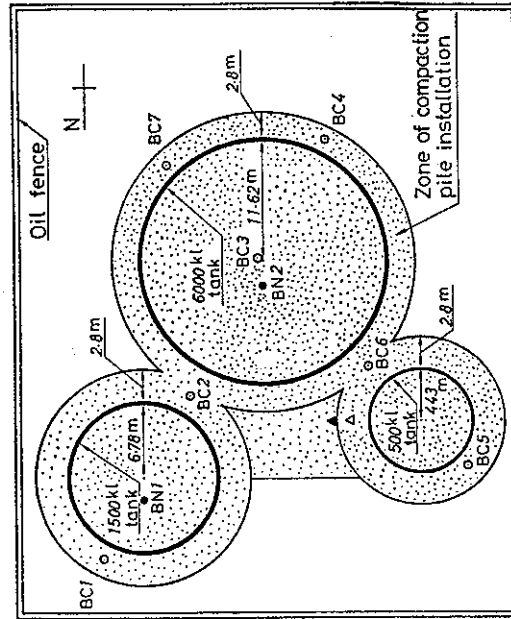
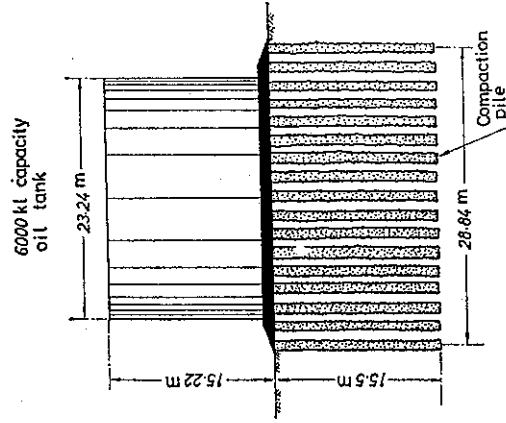
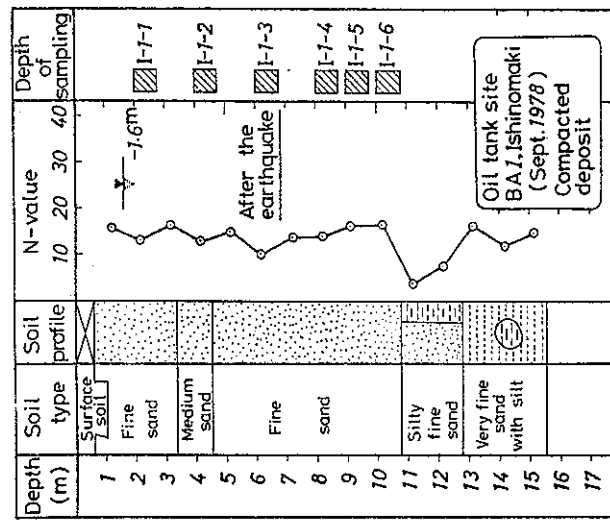
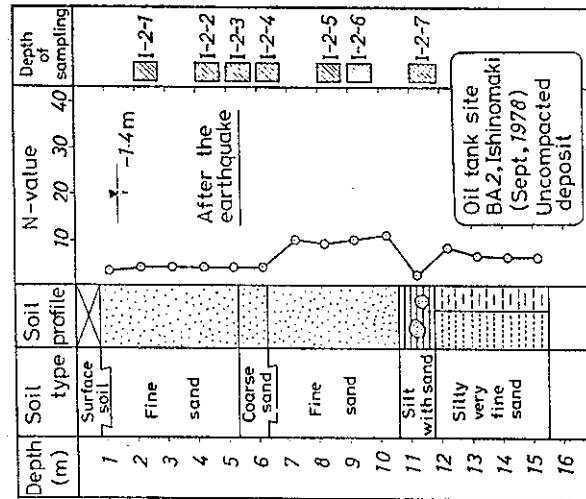
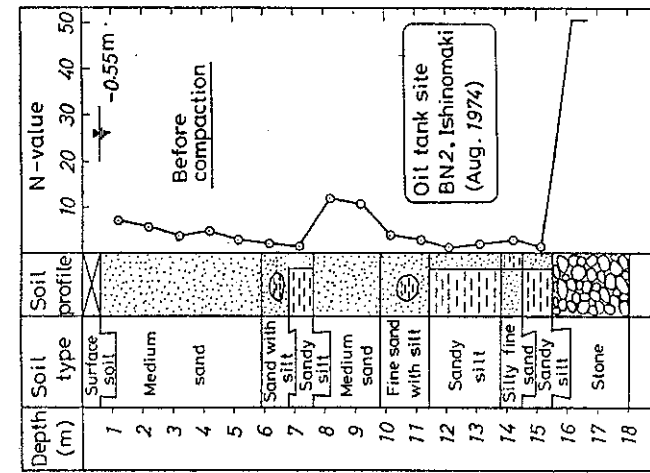
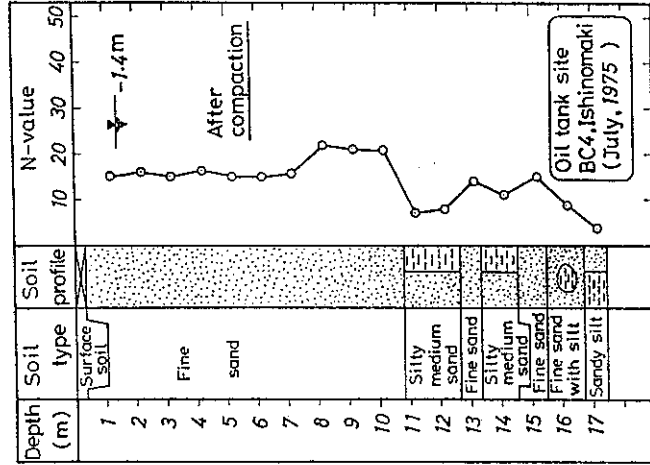
Comments	The attached liquefaction analyses used an average contact pressure of 60 kpa, and assumed it was uniform over the depth of interest.
Lessons learned	Treatment was able to prevent deformations while the untreated areas showed surface cracking and boils. Good performance is consistent with $FS_{liq} > 1$ over full depth if $a_{max} = 0.18$ g; if $a_{max} = 0.29$ g, then would expect liquefaction over much of the treated interval.

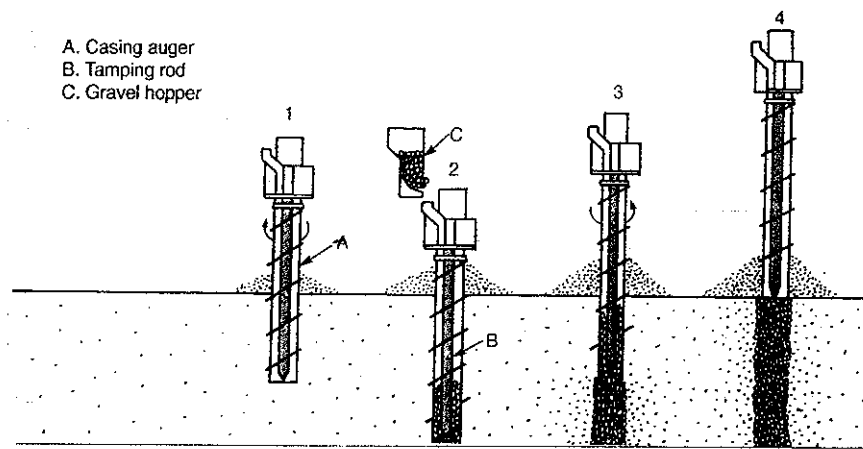
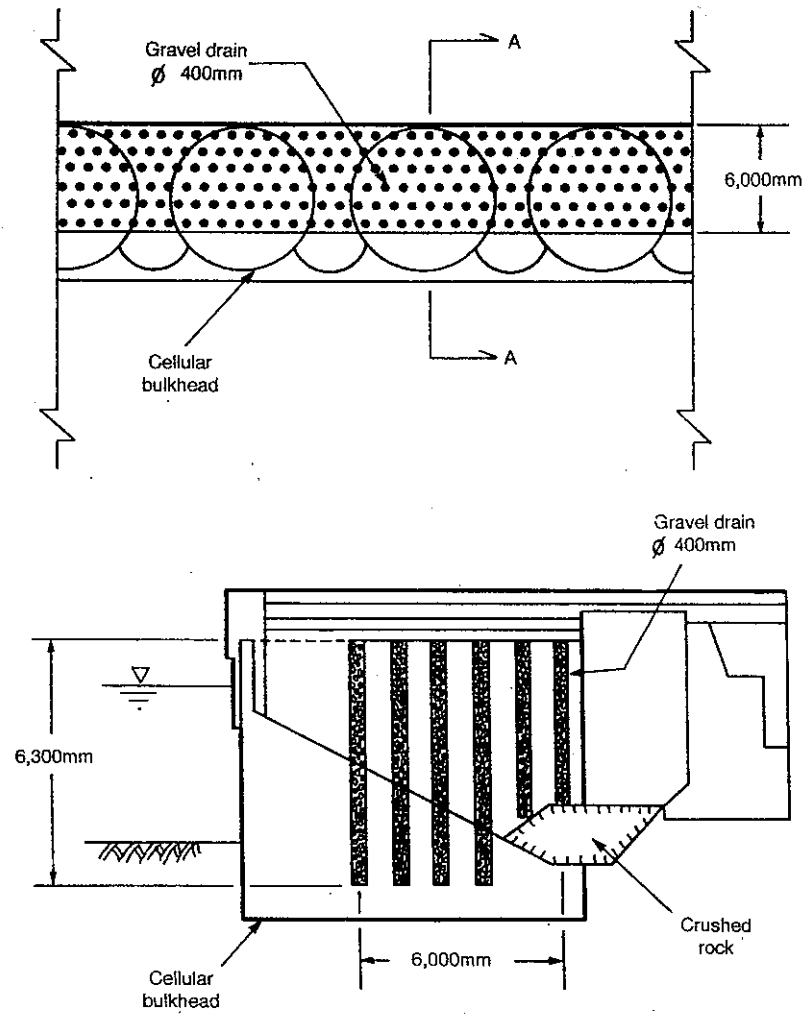
Fig. Gravel Drains at Port of Kushiro (Sonu et al. 1993)

Insitu test data	None published.
Comments	Need to obtain insitu test data, and address the role of the cellular cofferdams in restricting movements.
Lessons learned	Treatment appears to have been effective in preventing significant movements. Steel caissons may have helped, although they did not preclude settlement or movement at other locations.

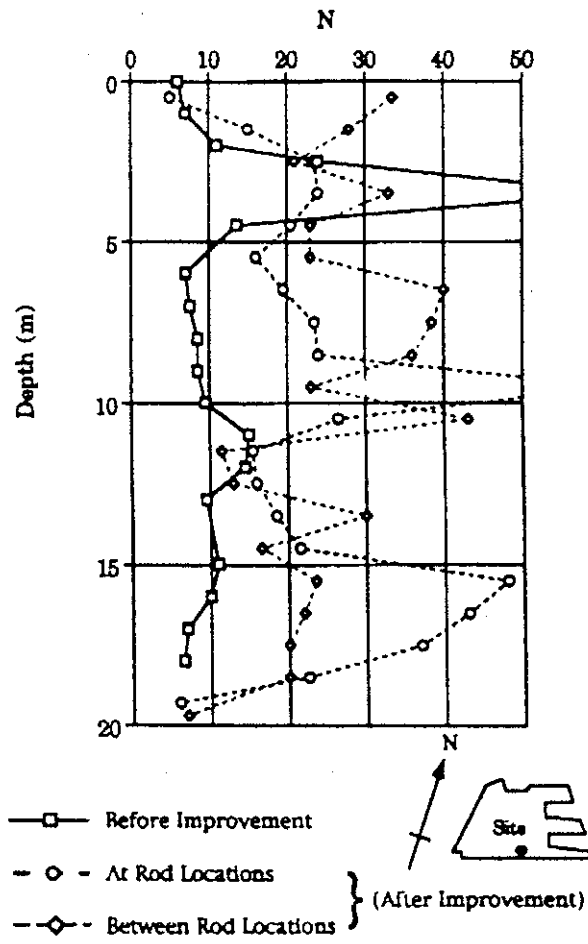
Fig. Amusement Park on Port Island (EERC 1995)

Insitu test data	1 SPT log before, and 2 SPT logs after treatment (1 in-between rod locations, and 1 at a rod location).
Comments	Need more data on the insitu testing, extent of treatment, and settlements. The attached liquefaction analyses include no surcharge from the buildings.
Lessons learned	Treatment greatly improved behavior of the site. Good performance is consistent with the $FS_{liq} > 1$ throughout the fill, except perhaps in isolated pockets. A stiff upper crust, well-designed shallow foundations, and uniform settlements could have contributed to the good performance. Liquefaction evidence along south side appears to have been within a distance equal to about 1/2 the thickness of liquefiable soil from the treatment boundary.

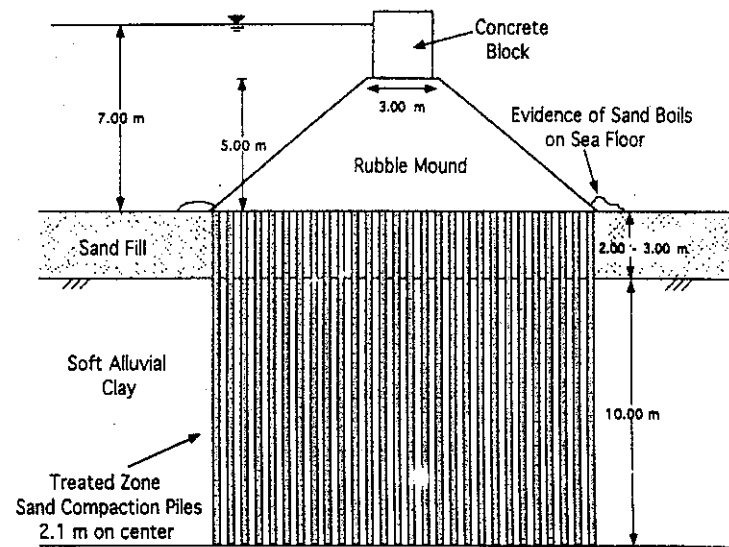
Fig. Rubble-Mound Breakwater in Nishinomiya Area
(EERC 1995)

Site & locations	Rubble-mound breakwater in the Nishinomiya area, near Kobe, Japan.
Earthquake	Hyogo-ken Nanbu (Kobe) Earthquake of 1995, $M_0=6.9$
Peak accel. at the site	
Facilities	Reinforced-concrete breakwater supported on a rubble-mound in about 7 m deep water.
Treatment method	Sand compaction piles; 2 m diameter, 2.1 m spacing, treatment over the base-width of the rubble mound.
Treated areas	Breakwater settled 1-2 m.
Untreated areas	Sand boils at the toe of the mound.
Sand fill, 2-3 m thick, over 10 m of soft clay.	No insitu test data published.
Insitu test data	None published.
Comments	Need to obtain insitu test data, and to address the roles of the soft clay and rubble-mound.
Lessons learned
